<b>Subject:</b>  <p style="text-align: center;"><b>IDLE FLUCTUATION/ENGINE VIBRATION</b></p>	<b>Bulletin No:</b> 01-023/07
	<b>Last Issued:</b> 06/08/2007

2006-2007 Mazda5 vehicles with VINs lower than JM1 CR\*\*\*\* \*\* 133752 (produced before August 4, 2006)

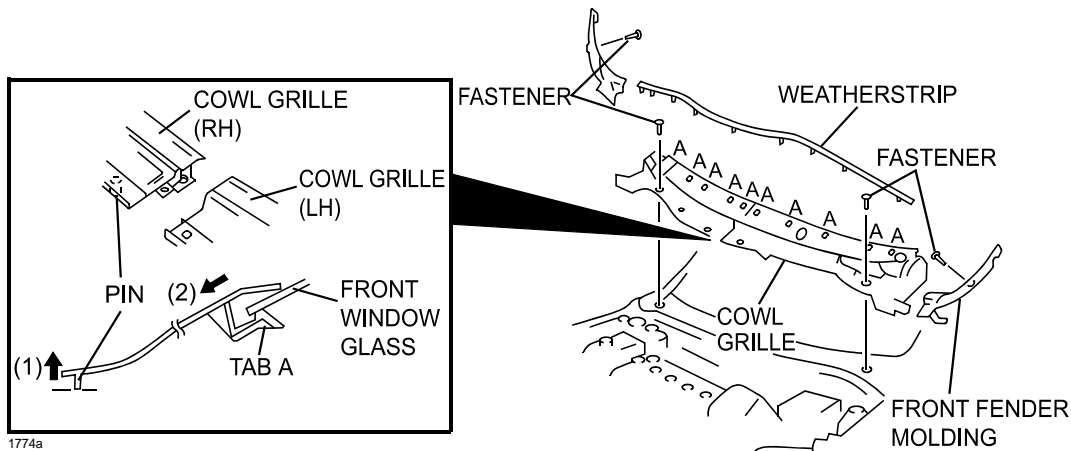
Some vehicles may experience idle fluctuation or engine vibration after the engine starts from a misfire caused by water settling around the No.1 plug after it rains or a car wash. The water enters the engine compartment because of poor sealing between the cowl grille and the hood. To prevent water from entering the engine compartment and settling around the No. 1 plug, a pad will be added on the cowl grille and the shape of the rubber seal for the ignition coil will be modified.

1. Verify customer concern.
2. Replace the No.1 ignition coil with a modified one.
3. Remove the left and right front wiper arms and blades. Refer to appropriate Workshop Manual section 09-19 - WINDSHIELD WIPER ARM AND BLADE REMOVAL/INSTALLATION.
4. Remove the front fender molding.

5. Remove the weatherstrip.
6. Remove the fasteners.
7. Remove both left and right cowl grilles by pulling up on the front and then pulling forward.
8. Add pads to the surface and back of the cowl grille as shown.
