Subject: ENGINE VIBRATION / KNOCKING NOISE / NO.3 ENGINE MOUNT RUBBER BROKEN	Bulletin No: 01-035/07
	Last Issued: 08/08/2007

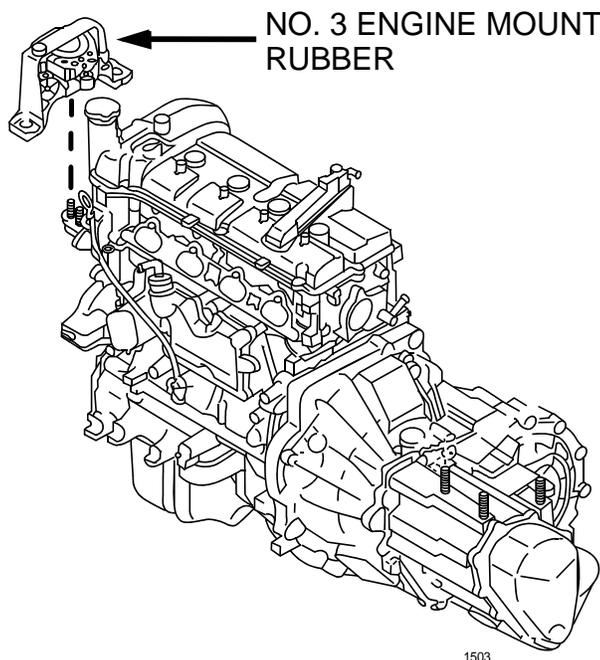
Some vehicles may exhibit a knocking noise from the engine compartment when starting/shutting off the engine or may experience excessive engine vibration at idle. A likely cause of this is a broken No. 3 engine mount. This symptom could be observed under any condition such as accelerating or idling with the engine hot or cold.

The No. 3 engine mount rubber has been modified to address this concern.

1. Verify concern.
2. Replace the No.3 engine mount rubber with a modified part. Refer to Workshop Manual section 01-10.
3. Verify repair.
