**Subject:****HEAVY STEERING EFFORT/POWER STEERING FLUID LEAKAGE****Bulletin No:** 06-003/08**Last Issued:** 02/18/2008**APPLICABLE MODEL(S)/VINS**

2004-2007 Mazda3 vehicles (except Mazdaspeed3) with VINs lower than JM1 BK\*\*\*\* \*\* 709745 (produced before February 1, 2007)

2006-2007 Mazda5 vehicles with VINs lower than JM1 CR\*\*\*\* \*\* 150635 (produced before February 1, 2007)

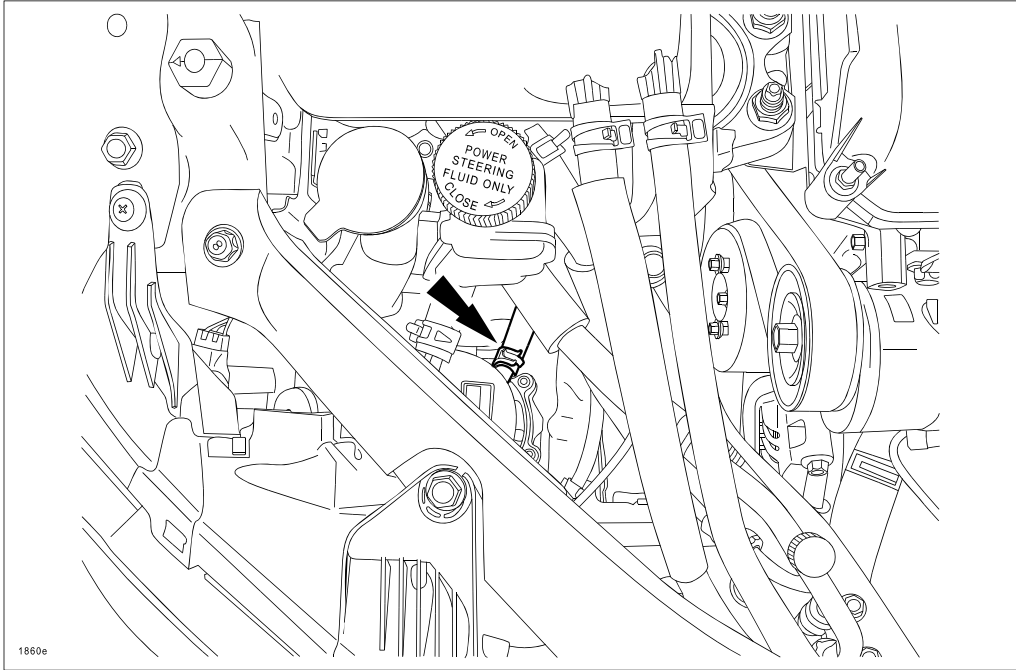
**NOTE:** Check for the leak at the return hose directly down from the power steering fluid reserve tank. If the leak is here, continue with this Service Bulletin. If the leak is not here, refer to MS3 online instructions or Workshop Manual section 06-14 POWER STEERING FLUID INSPECTION.

1. Verify concern by checking to see if the steering effort is hard and the power steering fluid level is low, indicating a leak.

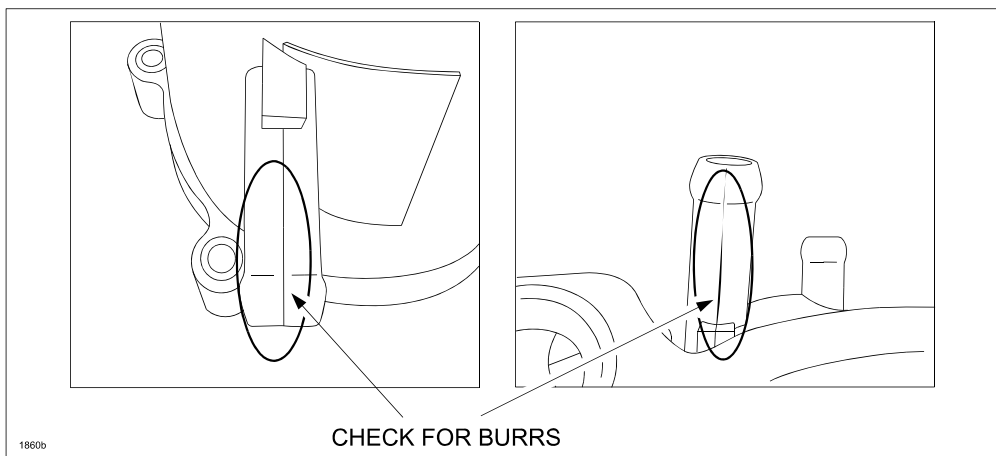
Some customers may feel the power steering effort is heavy. This can be caused by a fluid leak. One such leak can be caused by burrs found on the return port nipple of the fluid reservoir tank, making a gap between the return port and hose. All return ports are now inspected on the production line to ensure there is no burr.

**NOTE:** The parting lines are on the top and bottom of the port.

2. Drain the fluid from the electric power steering pump.
3. Remove the electric power steering oil pump. Refer to MS3 online instructions or Workshop Manual section 06-14 .
4. Run your finger over the parting lines on the return port to check for burrs.

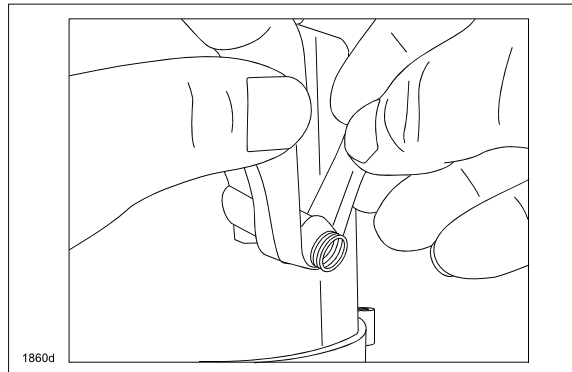
**CAUTION:** Do not sand any locations other than the burrs. If you sand too much, the shape of the return port will become deformed.

6. Place the sandpaper on one of the parting lines of the return port as shown and sand off the burrs (for approximately 1 minute) until the surface is smooth.
