<b>Subject:</b>  SEAT BELT RETAINER BREAKS	<b>Bulletin No:</b> 08-001/08
	<b>Last Issued:</b> 1/4/2008

2007 CX-9 with VINs before JM3 TB\*\*\*\* \*\* 117348 (produced before April 1, 2007)

2006-2007 Mazda5 with VINs before JM1 CR\*\*\*\* \*\* 153483 (produced before March 1, 2007)

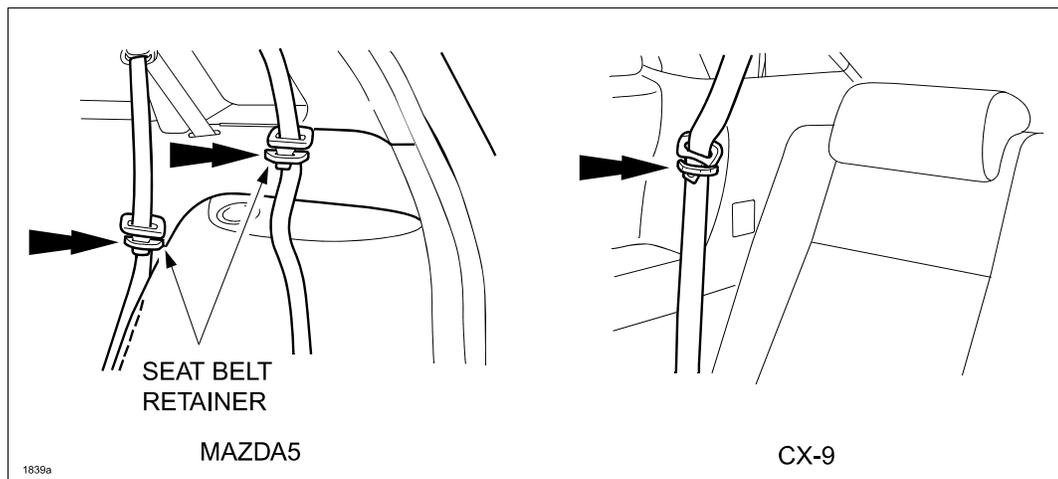
Some customer may complain that seat belt retainer clips for 2nd (Mazda5) or 3rd (CX-9, Mazda5) row seat are easily broken off. As a mass-production change, the construction of the seat belt retainer clip has been revised.

1. Verify customer concern.
2. Replace the broken seat belt clip with a modified one.

- The seat belt clip can only be installed in one direction.
