Subject: WHISTLING OR WIND NOISE FROM OUTER MIRROR	Bulletin No: 09-008/08
	Last Issued: 02/25/2008

APPLICABLE MODEL(S)/VINS

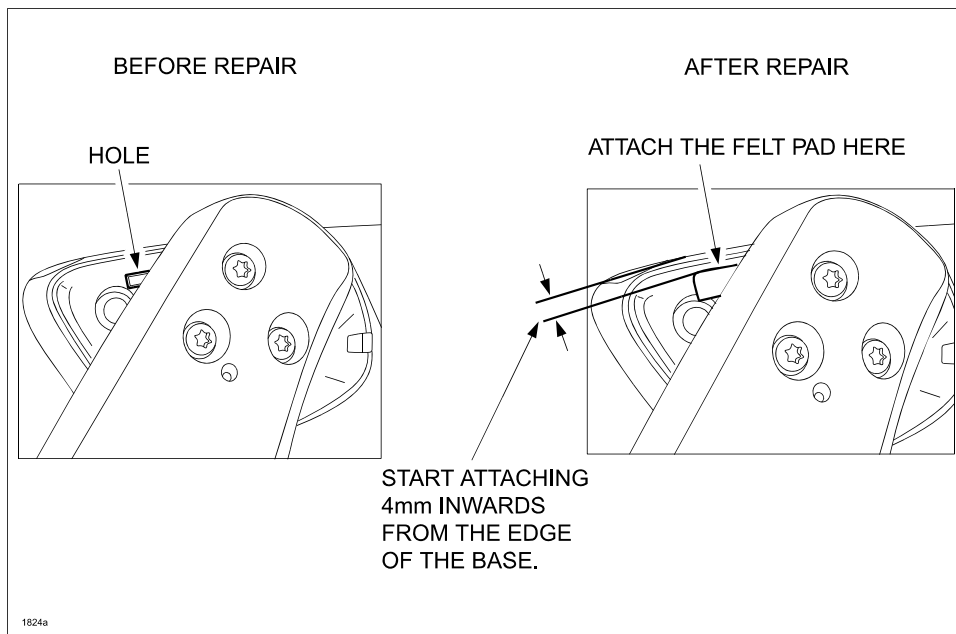
Some customers may complain about a whistling or wind noise from the outer mirrors when driving around 37 mph (60 km/h). A whistling noise is caused by an opening in the garnish-fitted hole under the mirror. On CX-7 only, a wind noise can also be caused by a gap in the harness-fitted rib groove on the outer mirror base.

1. Verify concern.
2. Cut the felt pad (thickness = 0.25mm) into a 8mm x 15mm piece for one side of vehicle repair.
3. Fold the outer mirror towards the vehicle.
4. Attach the felt pad (0.25mm x 8mm x 15mm) over the hole as shown.
