Subject: ENGINE UNDERCOVER HARD TO REMOVE	Bulletin No: 09-012/07
	Last Issued: 03/30/2007

2004 - 2007 Mazda3

2006 - 2007 Mazda5

2007 Mazdaspeed3

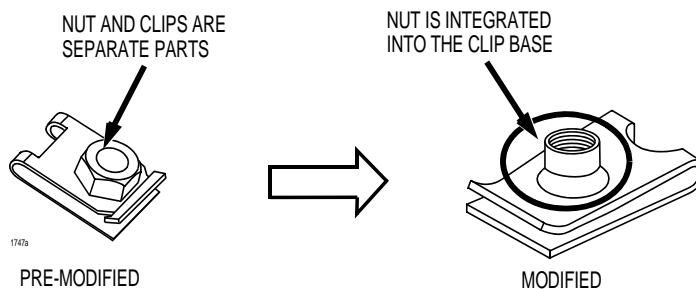
On some vehicles, the undercover may be hard to remove because the clip-nuts are rusted on the bolts due to road salt. When this happens, the complete clip spins or the spot weld breaks and the nut spins separately from the clip when loosening the bolts. The clip-nuts can be serviced separately from the undercover, and modified clip-nuts are now available with the thread integrated into the clip base.
