TAILLIGHT LENS WATER DROPLETS / AIR BUBBLES CONCERN

Bulletin No: 09-021/05

2006 Mazda5

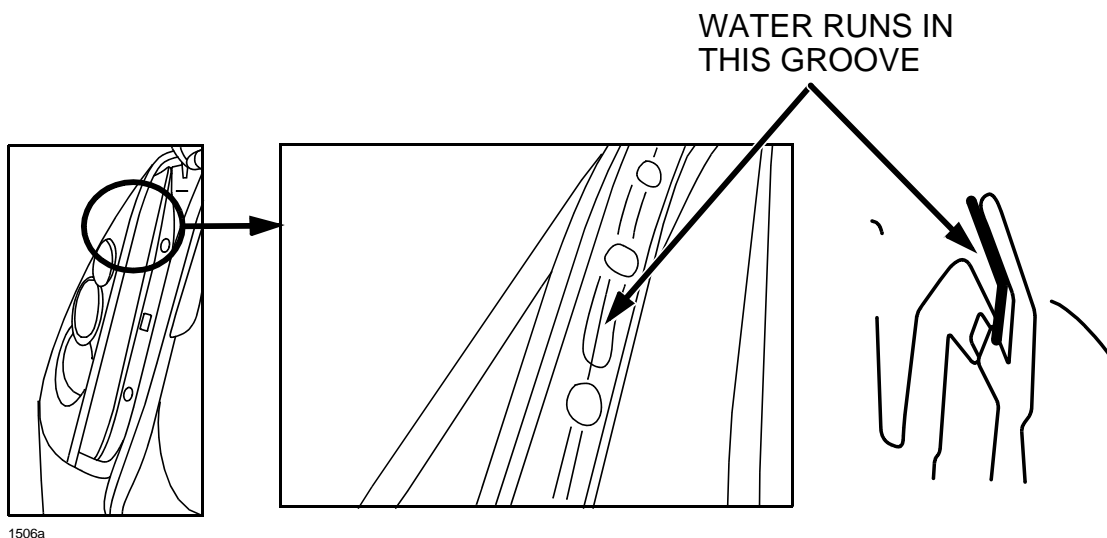
WATER DROPLETS

After washing the vehicle or driving it in the rain, moisture or water droplets may be visible on the outer edges of the taillight lenses.

Inform the customer that the water droplets will dry and disappear. The moisture is outside of the sealing area and **NOT** inside the taillight assembly. Taillight bulbs are not exposed to this moisture and their function is unaffected.

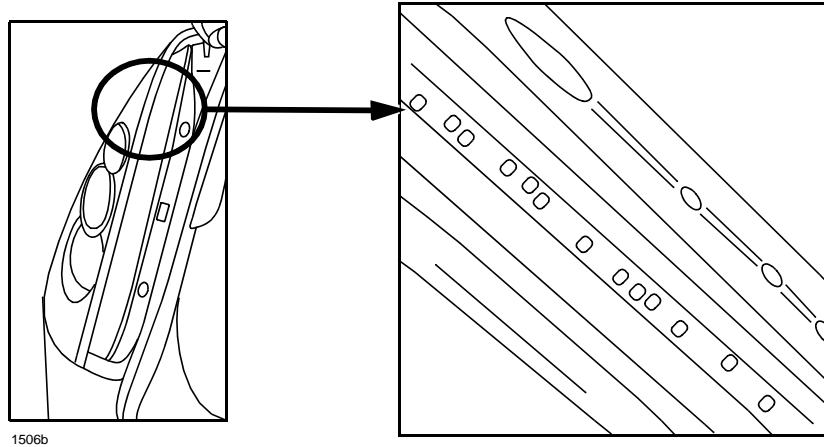
1506b

AIR BUBBLES

Tiny air bubbles may be seen within the plastic lenses of the taillights on their outer edges.

Inform the customer that when manufacturing the taillight, the lens is once melted when it is fitted to the lens casing. During the process air bubbles may become trapped in the lens. The presence of air bubbles does not affect lighting function.
