C-PILLAR TRIM DEFORMED ON RE-INSTALLATION

Bulletin No: 09-026/07

Last Issued: 07/13/2007

2006 – 2007 Mazda5

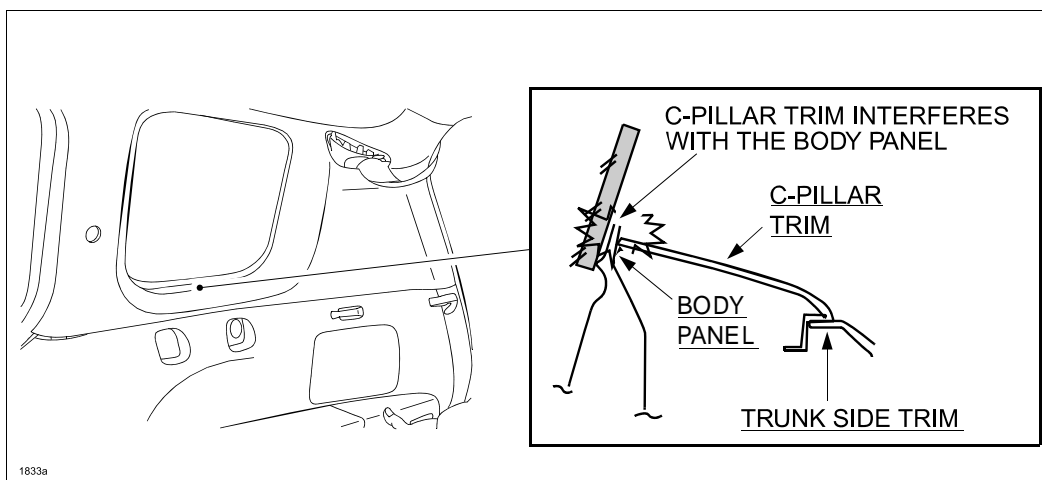
On some vehicles, improper alignment can result in the C-pillar trim deforming around the window on reinstallation. Deforming occurs if the trim is fitted in the vehicle with the lower part pressed against the body panel.

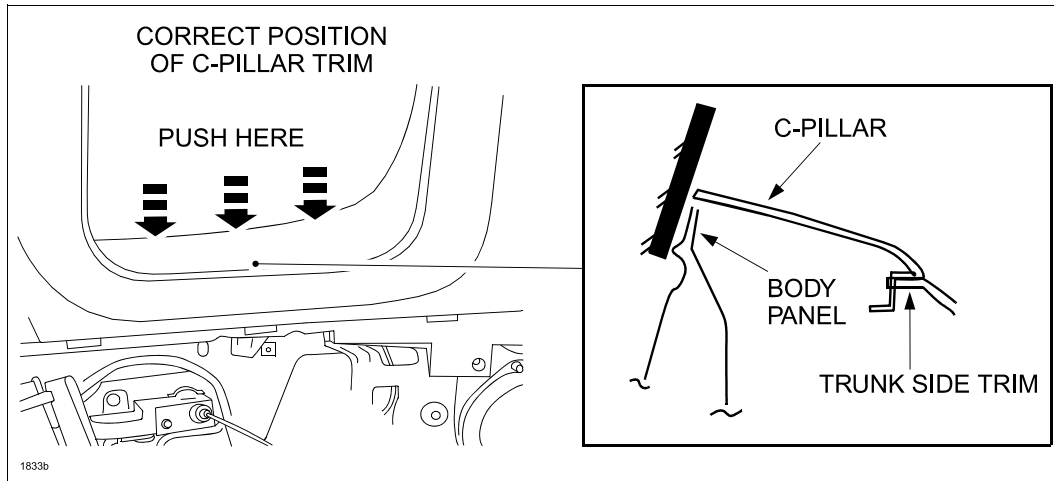
1. After installing the C-pillar trim, push on the indicated area.

- a. If it can be pushed in and touches the body panel, it is installed correctly.
 - b. If it gets stuck, the C-pillar trim may be interfering with the body panel.
2. If necessary, remove the trunk side trim and push up the C-pillar trim to make sure it is placed over the body panel.
