<b>Subject:</b> <b>2013-2014 CX-5 - VARIOUS ELECTRICAL SYSTEM MALFUNCTION(S) RELATED TO C-15 CONNECTOR CORROSION</b>	<b>Bulletin No:</b> 09-041/15 <b>Last Issued:</b> 10/14/2015
---	---

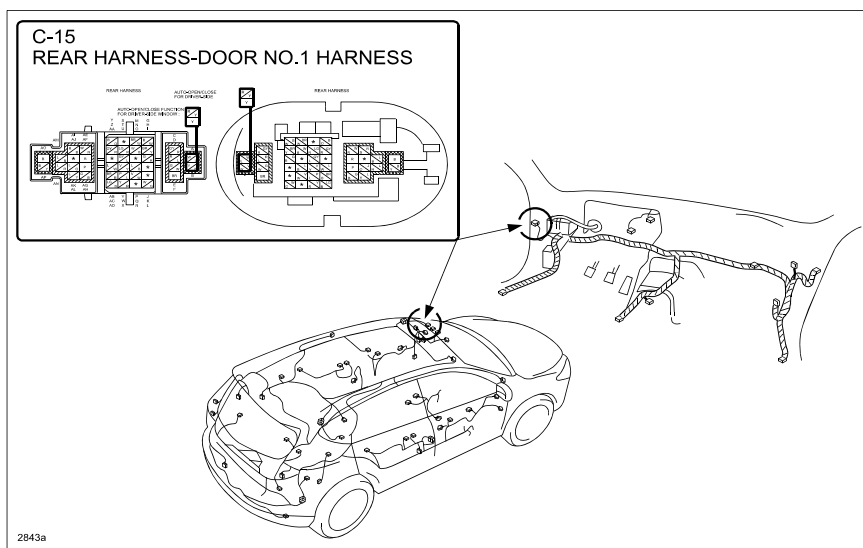
- The driver side power window does not operate.
- The door does not open when using the advanced keyless system.
- The warning lamp stays ON even after the ignition switch is turned OFF.
- DTC B10E7:17 (START STOP UNIT, IG1 Relay Circuit Malfunction) and DTCs related to communication errors may be stored in PCM memory.

The symptoms listed above may be caused by corrosion of the C-15 connector terminals due to water intrusion through the front door. In low ambient temperatures, the door harness hardens. If the door is fully opened, it may create a gap between the door and the door harness grommet, which may allow water to enter through the gap.

- If there is any corrosion at the C-15 connector, replace the door harness and repair the rear harness according to the following repair procedure.
  - If there is no corrosion found at the C-15 connector, this bulletin is not applicable. Troubleshoot the concern(s) according to the MS3 online instructions or the Workshop Manual.
1. Verify the customer concern.
  2. Record customers pre-set radio stations.
  3. Slide the driver side front seat fully backwards.
  4. Disconnect the negative battery cable.
  5. Disconnect the C-15 connector according to the MS3 online instructions or the Workshop Manual (section 09-11 FRONT DOOR REMOVAL/INSTALLATION).
  6. Inspect for any corrosion found on the terminals shown below.

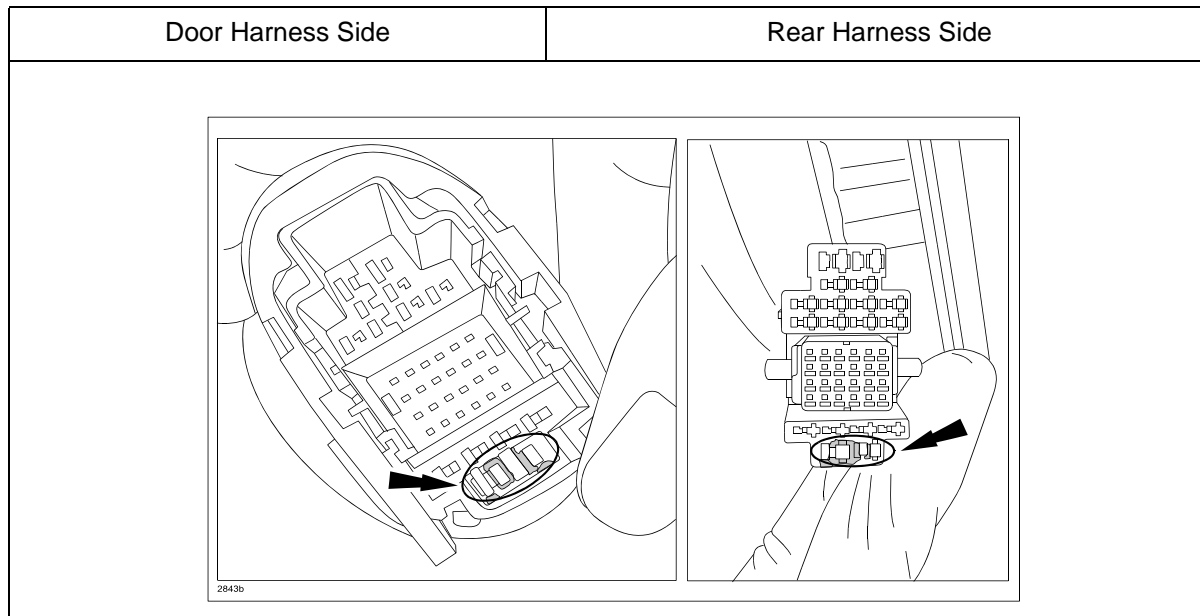
- If there is any corrosion found on the terminals, go to next step.
- If there is no corrosion found on the terminals, this bulletin is not applicable. Troubleshoot the concern(s) according to the MS3 online instructions or the Workshop Manual.
