Technical Service Bulletin

**CLUNKING NOISE FROM FRONT SUSPENSION WHEN DRIVING
OVER BUMPS**

Bulletin No.: 02-012/18

2017-2018 CX-5 vehicles with VINs lower than JM3KF*****353182 (produced before February 1, 2018)

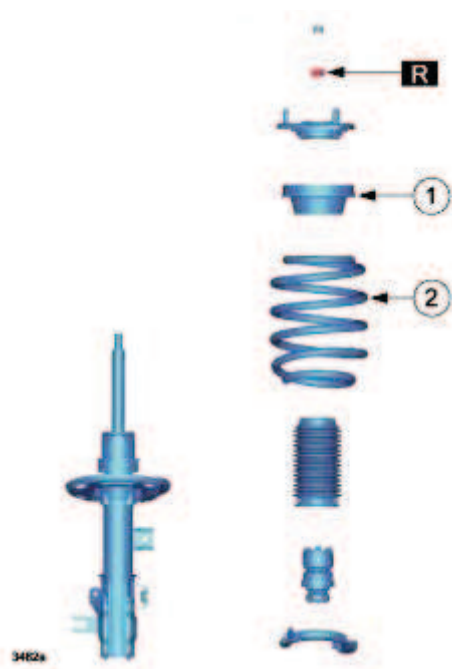
Some vehicles may exhibit a clunking noise from the front coil springs when driving over bumps. The noise is due to stick-slip between the front strut bearing (1) and the coil spring (2).

To eliminate the noise, protectors have been installed onto the coil spring.
