# Service Information

Category <b>P</b>	<b>Repair Guidance</b>	Ref. No. R052/16 <b>C</b>	Page 1 of 6
Coverage <input type="checkbox"/> Distributor only <input checked="" type="checkbox"/> Please inform your dealers		Date Issued June 20, 2016	
Please convey this information to your <input checked="" type="checkbox"/> Warranty Dept. <input checked="" type="checkbox"/> Parts Dept. <input checked="" type="checkbox"/> Training Dept. <input checked="" type="checkbox"/> Field Rep.	<input type="checkbox"/> Director <input checked="" type="checkbox"/> General Manager	Date Revised February 24, 2017	
Applicable Model  CX-5 (KE) with Electric Parking Brake (EPB)	Applicable Countries or Specifications  Worldwide

## Subject: Noise from REAR BRAKE/Trace of Rear Brake Dragging

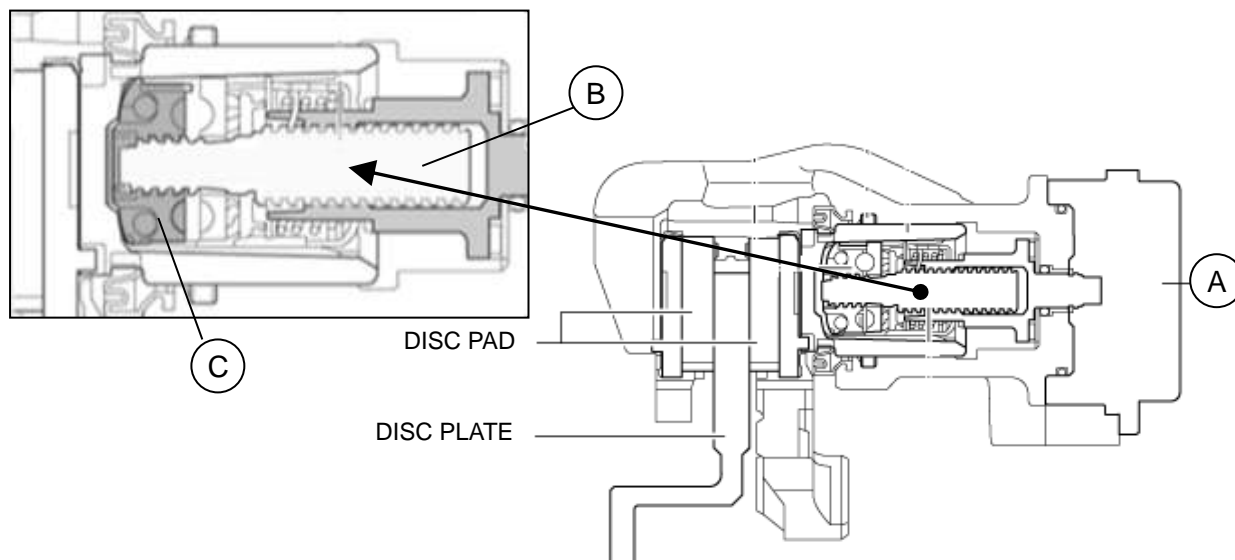
**This concern is caused by the EPB being not completely released.**

**The EPB control module judges that the parking brake is completely released when the current value flown to the motor (A) drops to the threshold, namely when the rotating torque of the spindle (B) drops.**

**Due to insufficient accuracy of the screw threads of the ball and ramp (C), the spindle (B) may idle momentarily during the EPB release operation causing the spindle rotating torque (the current value to the motor) to drop to the threshold before completely releasing the parking brake.**

The ball and ramp has been modified to improve the accuracy of screw threads.

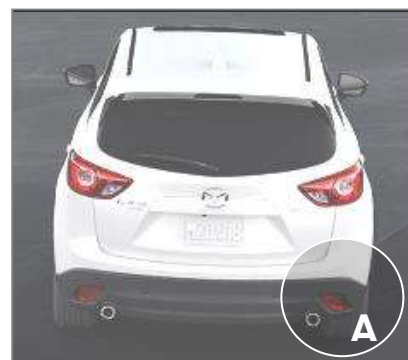
In this case, the right side EPB (A) is released late/incorrect so the vehicle rolls to the right.

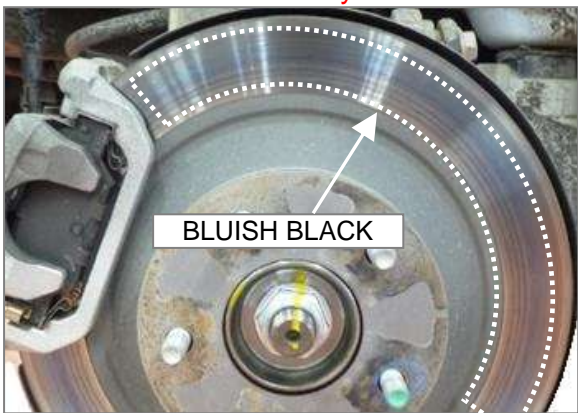
DISC PLATE	
<p>Area contacting disc pad is discolored to bluish black by heat</p>

If the caliper has been found to be defective by the diagnosis procedure, replace the affected side caliper(s) with a modified one(s) according to the workshop manual “REAR BRAKE (DISC) REMOVAL/INSTALLATION” and “ELECTRIC PARKING BRAKE MOTOR GEAR UNIT REMOVAL/INSTALLATION”.

**NOTE:** If the disc plate(s)/disc pad are damaged, inspect and replace the affected side(s) as necessary according to the workshop manual “REAR BRAKE (DISC) REMOVAL/INSTALLATION” and “DISC PAD (REAR) REPLACEMENT”.

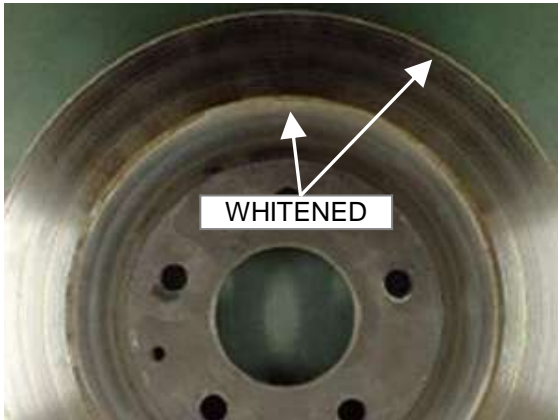
<p>BLUISH BLACK</p>	<p>Area not contacting disc pad is whitened by heat.</p>

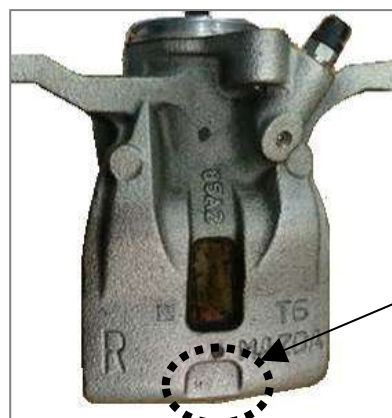
**NOTE:** Part numbers of caliper have not been changed by this modification. Distinguish the modified one from old one using the 3-digit lot number (Production Date) stamped on the caliper. Calipers with the lot number (production date) of 697 (2016/09/07) and higher are modified.

**6 9 7 = 2016/09/07**

↑     ↑     ↑  
 Date:     7 = 7  
 Month:    9 = September  
 Year:     6 = 2016
