Service Information

| Category P | Technical | Ref. No. E005/18A | Page 1 of 2 |
| Applicable Model CX-5 (KE/KF) and CX-9 (TC) with Electric Parking Brake | | Applicable Countries and/or Vehicle Specifications Worldwide | |

Subject: Caution when performing Electric Parking Brake (EPB) Forced Release

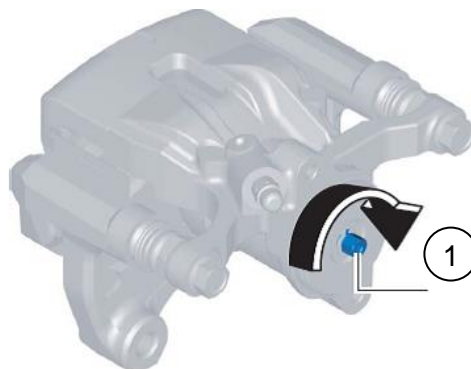
DO NOT release the spindle too much.

Rotate the spindle (1) only **one (1) turn** in the direction of the arrow shown in the figure.

Although the Workshop Manual "ELECTRIC PARKING BRAKE FORCED RELEASE PROCEDURE" instructs to rotate the spindle approx. 2-3 times, this is wrong information and it will be corrected soon.

If the spindle is released too much beyond one (1) turn, replace the brake caliper with a new one since the brake caliper may be damaged.

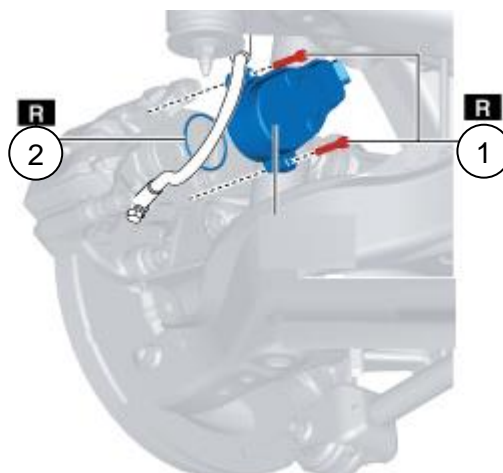
DO NOT reuse parts marked [R]

Replace two bolts (1) and O-ring (2) with new ones when reinstalling the EPB Motor Gear Unit.
