Service Information

Category S	Repair Guidance	Ref. No. R042/13	Page 1 of 6
Coverage <input type="checkbox"/> Distributor only <input checked="" type="checkbox"/> Please inform your dealers		Date Issued June 21, 2013	
Please convey this information to your <input type="checkbox"/> Director <input checked="" type="checkbox"/> General Manager <input checked="" type="checkbox"/> Warranty Dept. <input checked="" type="checkbox"/> Parts Dept. <input checked="" type="checkbox"/> Training Dept. <input checked="" type="checkbox"/> Field Rep.		Date Revised	
Applicable Model CX-5 (KE)	Applicable Countries or Specifications Europe

Subject: Outer mirror vibration when driving on highway

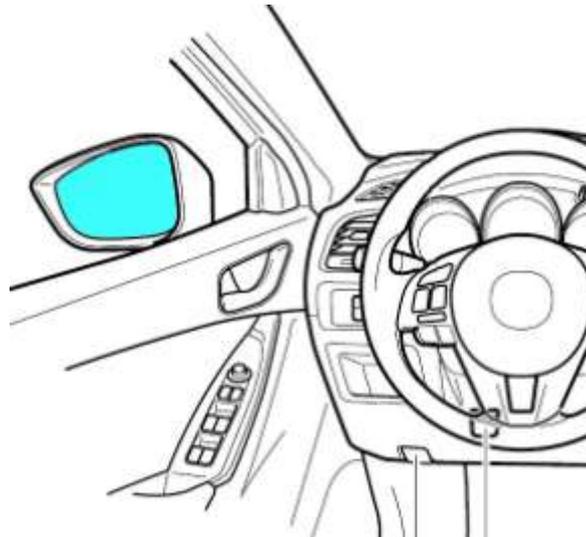
Some vehicles may exhibit a vibration on outer mirror when the vehicle is driven at high speed.

Due to a lack of rigidity of the outer mirror base, the mirror vibrates caused by vehicle vibration or wind pressure.

Depending on VIN, perform all applicable repair(s) according to the following chart.
