Subject: A/C STOPS COOLING/REDUCED AIRFLOW DURING A LONG DRIVE IN HUMID TEMPERATURES	Bulletin No: 07-011/09
	Last Issued: 09/18/2009

2006 - 2009 Mazda3 vehicles (including Mazdaspeed3)

2006 - 2009 Mazda5 vehicles with VINs lower than JM1CR ***** 348679 (produced before November 1, 2008)

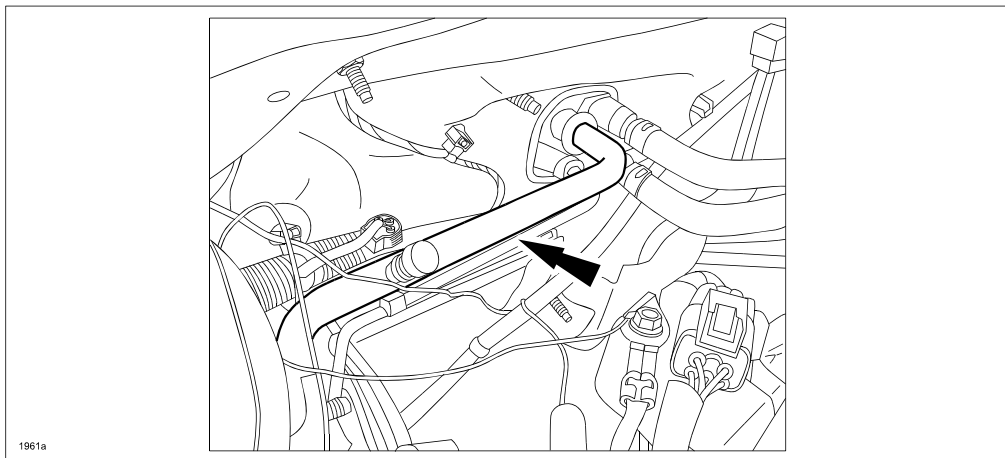
- During freeze-up, the low pressure side pipe will have frost on it, giving the appearance it is frozen.
- Allowing the evaporator to unfreeze will temporarily address the concern.

The cause of the evaporator freeze-up is product variation of the evaporator temperature sensor and uneven airflow across the evaporator. To correct the sensor, a short harness with a built-in resistor will need to be installed in series with evaporator temperature sensor circuit. This cord will correct it by reducing the measured value 1°C (1.8°F). To correct the airflow, a cabin filter with a built-in diffuser will need to be installed in place of the current filter.
