Service Information

Mazda Motor Corporation

Category F	Technical	Ref. No. E023/17	Page 1 of 4
Coverage <input type="checkbox"/> Distributor only <input checked="" type="checkbox"/> Please inform your dealers		Date Issued December 13, 2017	
Please convey this information to your <input type="checkbox"/> Director <input checked="" type="checkbox"/> General Manager <input checked="" type="checkbox"/> Warranty Dept. <input checked="" type="checkbox"/> Parts Dept. <input checked="" type="checkbox"/> Training Dept. <input checked="" type="checkbox"/> Field Rep.		Date Revised	
Applicable Model All Models equipped with SKYACTV-G Engines of Direct Fuel Injection System		Applicable Countries and/or Vehicle Specifications Worldwide

Subject: Engine Oil Dilution with Fuel

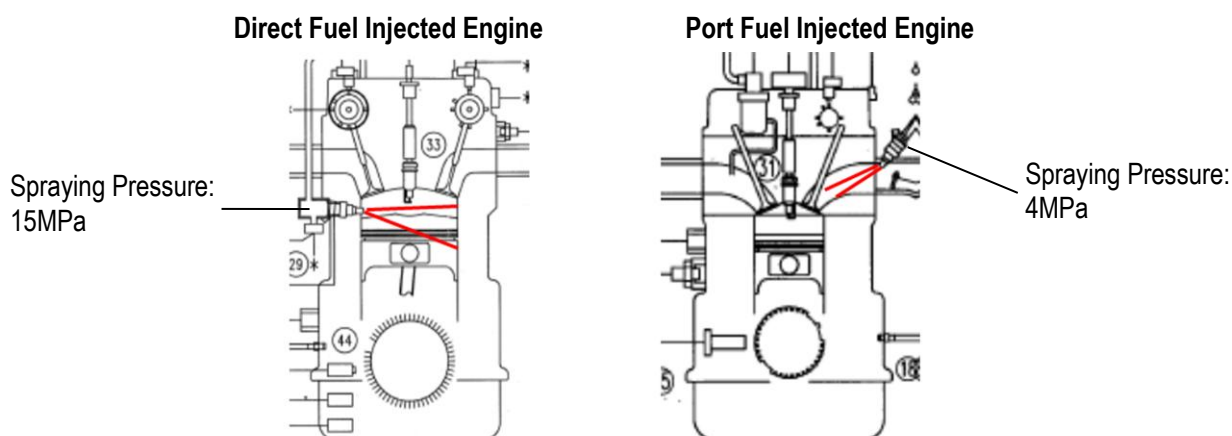
A direct fuel injected gasoline engine is designed that high-pressurized fuel is injected directly into the combustion chamber, which may cause the fuel to adhere to the cylinder wall. The fuel is then scraped by the piston, flows down into the crankcase and mixes with the engine oil causing "an engine oil dilution with fuel".

On the contrary for a port fuel injected gasoline engine, a fuel is injected toward the upstream of the intake valve and so it is unlikely to have fuel adhering to cylinder walls.
