# Service Information

Category <b>F</b>	<b>Technical</b>	Ref. No. E023/17	Page 1 of 4
Coverage <input type="checkbox"/> Distributor only <input checked="" type="checkbox"/> Please inform your dealers		Date Issued <b>December 13, 2017</b>	
Please convey this information to your <input type="checkbox"/> Director <input checked="" type="checkbox"/> General Manager <input checked="" type="checkbox"/> Warranty Dept. <input checked="" type="checkbox"/> Parts Dept. <input checked="" type="checkbox"/> Training Dept. <input checked="" type="checkbox"/> Field Rep.		Date Revised	
Applicable Model All Models equipped with SKYACTV-G Engines of Direct Fuel Injection System		Applicable Countries and/or Vehicle Specifications Worldwide

## Subject: Engine Oil Dilution with Fuel

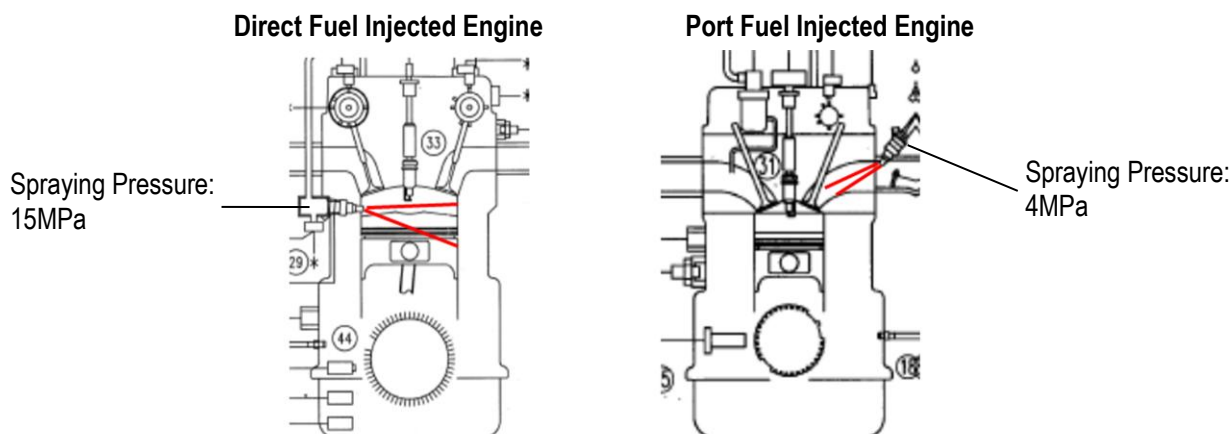
A direct fuel injected gasoline engine is designed that high-pressurized fuel is injected directly into the combustion chamber, which may cause the fuel to adhere to the cylinder wall. The fuel is then scraped by the piston, flows down into the crankcase and mixes with the engine oil causing "an engine oil dilution with fuel".

On the contrary for a port fuel injected gasoline engine, a fuel is injected toward the upstream of the intake valve and so it is unlikely to have fuel adhering to cylinder walls.

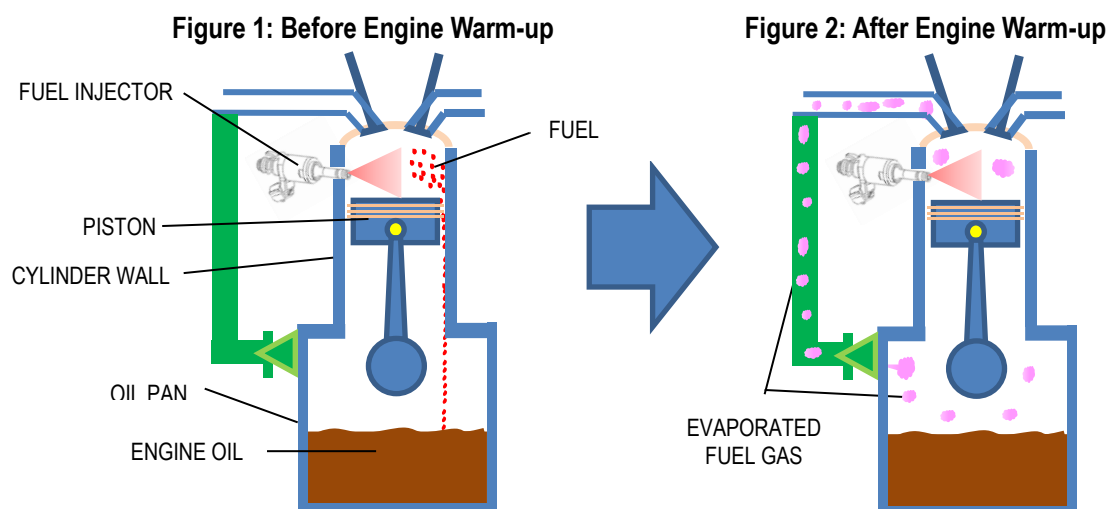
**Figure 1:** While the engine is not warmed up yet, fuel flows down between the piston and cylinder wall and enters in the oil pan mixing with the engine oil.

**Figure 2:** After the engine is warmed up, fuel content in the engine oil evaporates by engine operating temperatures and the evaporated fuel gas is sucked into the combustion chamber and burnt off. At this time, the amount of fuel injected by fuel injector is adjusted according to the amount of fuel evaporated from the engine oil and entered in the combustion chamber.

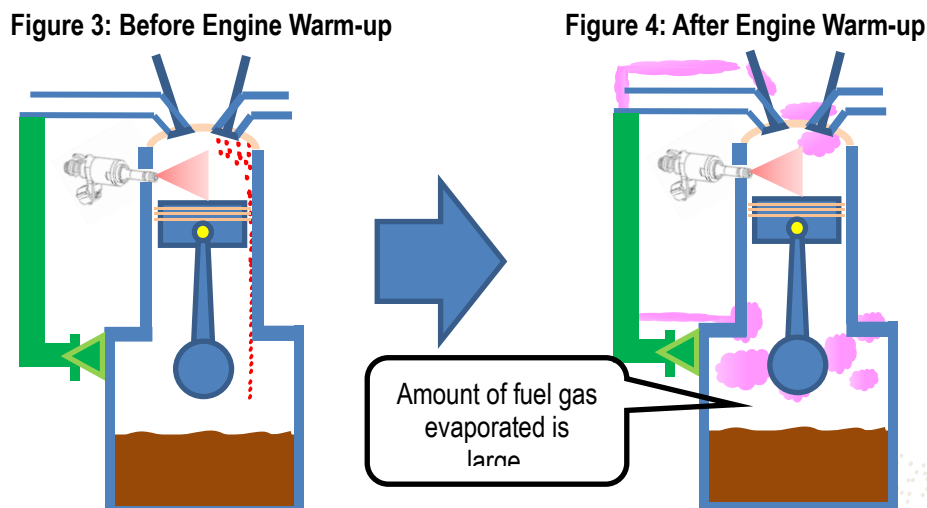
**Figure 3:** In this case, fuel content in the engine oil does not evaporate actively and so the amount of fuel remaining in the engine oil is increased (Engine oil level is increased).

**Figure 4:** After the engine is warmed up, a larger amount of fuel content in the engine oil evaporates and is burnt off in the combustion chamber. In this case if the amount of fuel evaporated exceeds the limit that the fuel injector can adjust by changing the injection amount, the system turns on the warning light.

In winter time, if a lot of short trips with the engine running in cool condition, are taken, it causes a condition that an engine oil dilution with fuel is likely to occur resulting in the accelerated engine oil deterioration. Therefore, it is recommended to immediately check and replace the engine oil when the check engine light is illuminated.
