Service Information

Category T	Repair Guidance	Ref. No. R027/18A	Page 1 of 4
Coverage <input type="checkbox"/> Distributor only <input checked="" type="checkbox"/> Please inform your dealers		Date Issued May 15, 2018	
Please convey this information to your <input type="checkbox"/> Director <input checked="" type="checkbox"/> General Manager <input checked="" type="checkbox"/> Warranty Dept. <input checked="" type="checkbox"/> Parts Dept. <input checked="" type="checkbox"/> Training Dept. <input checked="" type="checkbox"/> Field Rep.		Date Revised July 13, 2018	
Applicable Model CX-5 (KF)		Applicable Countries and/or Vehicle Specifications Worldwide

Subject: Foggy Lens of Rear Combination Lights

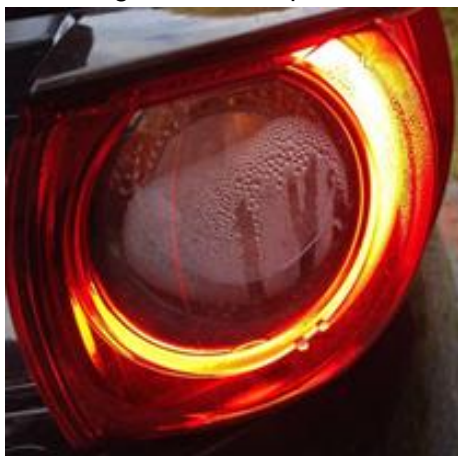
1. Confirm if the condensation is running down.
IF YES, replace the whole rear combination lights unit according to the workshop manual "REAR COMBINATION LIGHT REMOVAL/INSTALLATION".
IF NOT, go to next step.

Need to replace the unit

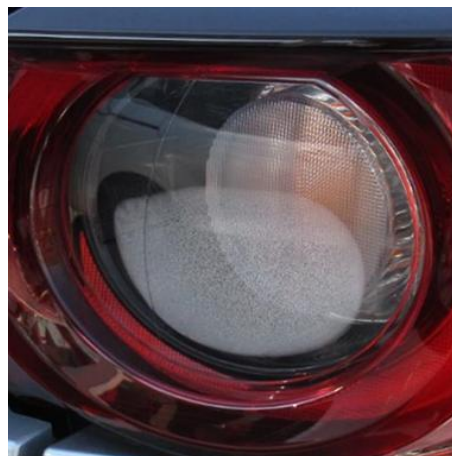
NO need to replace the unit
