Service Information

Category S	Repair Guidance	Ref. No. R014/18	Page 1 of 3
Coverage <input type="checkbox"/> Distributor only <input checked="" type="checkbox"/> Please inform your dealers		Date Issued March 6, 2018	
Please convey this information to your <input type="checkbox"/> Director <input checked="" type="checkbox"/> General Manager <input checked="" type="checkbox"/> Warranty Dept. <input checked="" type="checkbox"/> Parts Dept. <input checked="" type="checkbox"/> Training Dept. <input checked="" type="checkbox"/> Field Rep.		Date Revised	
Applicable Model CX-5 (KF) with manual seats	Applicable Countries and/or Vehicle Specifications Worldwide

Subject: Front Seat Cushion Trim at the bottom back coming off

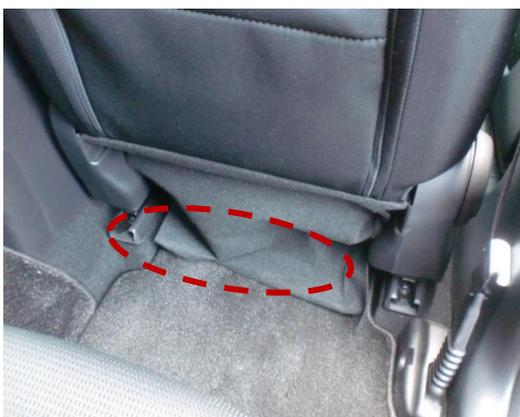
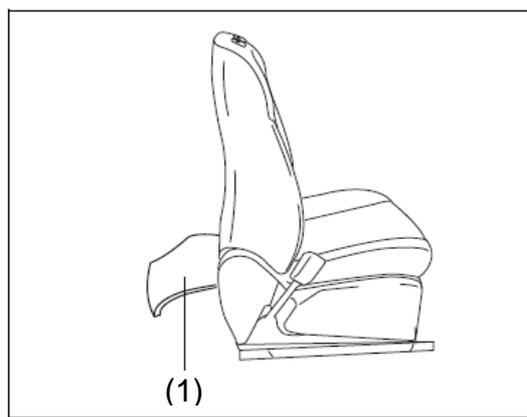
ac5wzw0000701

Some vehicles may exhibit a condition that the driver and/or passenger seat cushion trim at the bottom back (1) comes off the seat cushion frame.

The front seat cushion trim at the bottom back is attached to the seat cushion frame using a hook. The hook may slip out of the seat cushion frame due to insufficient holding power.

A plastic band is added to increase holding power.
