| <b>Subject:</b><br><br><b>HOOD VIBRATION WHILE DRIVING AT HIGHWAY SPEED</b> | <b>Bulletin No:</b> 09-029/12 |
| | <b>Last Issued:</b> 07/27/2012 |

2013 CX-5 vehicles with VINs lower than JM3KE\*\*\*\*\*120257 (produced before April 18, 2012)

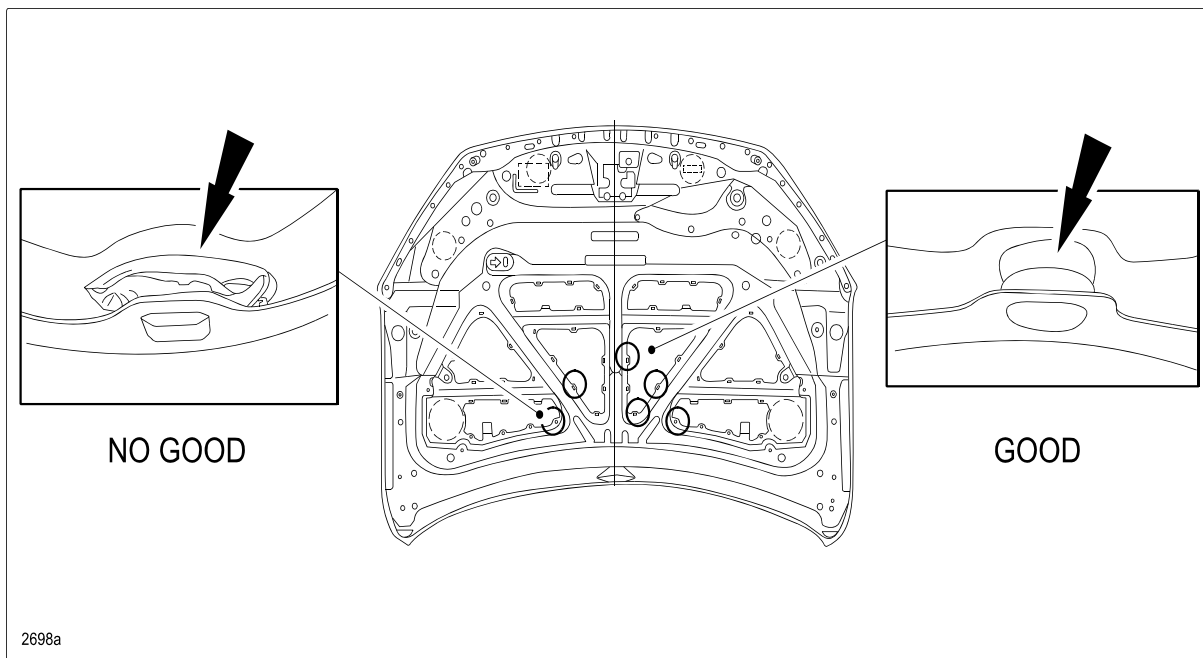
The amount of sealant used to fill in the space between the inner frame and outer panel at the bottom area of the hood is insufficient. If the sealant detaches (as shown below on the left), it may cause the hood to vibrate. The amount of sealant has been increased during vehicle production to eliminate the concern.

Customers having this concern should have their vehicle repaired using the following repair procedure.

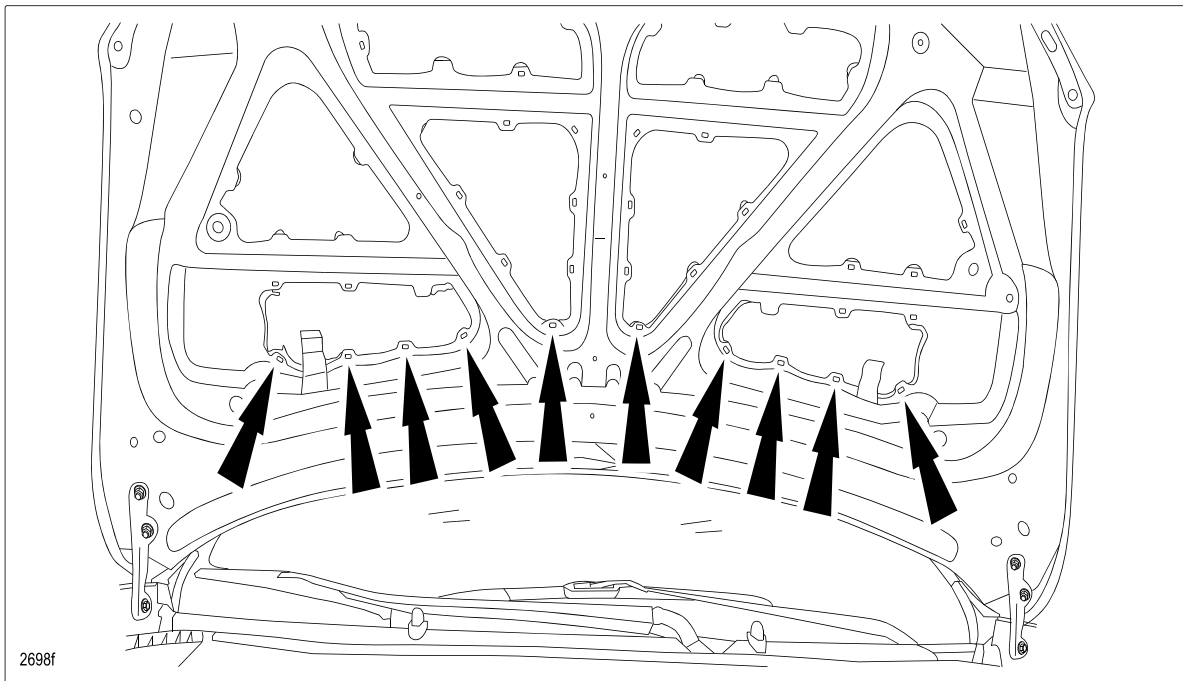
1. Verify the customer concern.
2. Open the hood and secure it with the support rod.
3. Remove the hood insulator according to the MS3 online instructions or the Workshop Manual (section 09-10 HOOD DISASSEMBLY/ASSEMBLY).
4. Confirm the ten (10) original sealant spots at the bottom area of the hood.

- Additional dampening material will be applied **between** these ten (10) original sealant spots.
- It is not necessary to apply dampening material to other areas of the hood. Even if the original sealant has become detached, it will have no influence on the hood vibration concern.
