Technical Service Bulletin

Subject: COOLANT LEAKS AT CYLINDER HEAD	Bulletin No.: 01-013/21
	Last Issued : 12/02/2021

Subject: WATER PUMP COOLANT LEAK	Bulletin No: 01-016/16
	Last Issued: 08/26/2016

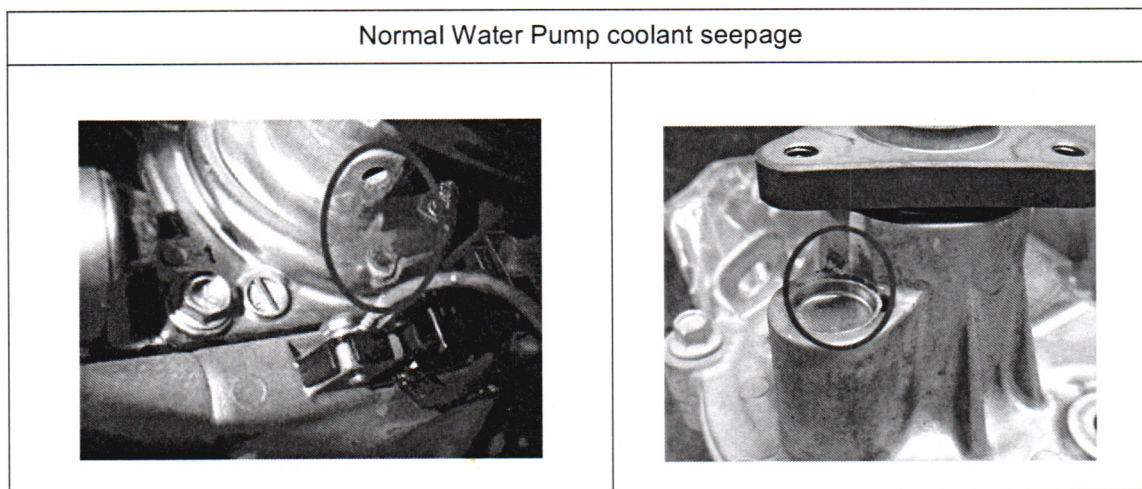
There is a concern that some water pumps are being replaced that are not faulty, due to signs of a very small coolant leak from the bleed hole. This Service Bulletin is to inform you about the water pump sealing mechanism and the criteria if replacement is necessary or not.
