01-019/12 - 2012 MAZDA5 - MIL ON WITH DTC P0451:00

TSB NUMBER: 01-019/12

2012 Mazda5 vehicles with VINs lower than JM1CW*****138553 (produced before April 10, 2012)

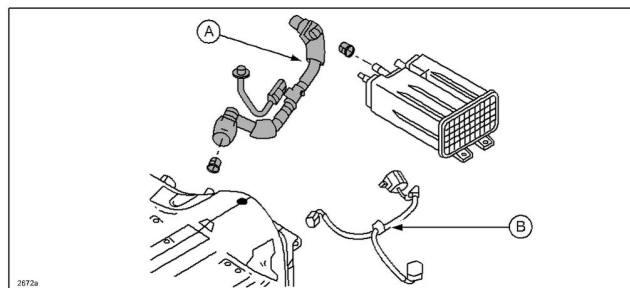
Some vehicles may experience the MIL on with DTC P0451:00 stored in memory. This is caused by foreign material adhering to the fuel tank pressure (FTP) sensor. To prevent this from happening, the installation angle of the FTP sensor has been changed.

1. Verify customer concern.
2. Disconnect the negative battery cable.
3. Lift the vehicle up on a hoist.
4. Remove the original evaporation hose assembly (A) and short cord (B), and discard them. Refer to MGSS online instructions or Workshop Manual section 01-16 [CHARCOAL CANISTER REMOVAL/INSTALLATION \[MZR 2.5\]](#).

5. Install the modified evaporation hose assembly (with FTP sensor) and short cord.
6. Lower the vehicle.
