Subject: SQUEAKING NOISE FROM FRONT SUSPENSION WHEN PASSING OVER A BUMP	Bulletin No: 02-002/06
	Last Issued: 3/22/2006

2004-2006 Mazda3 vehicles with VINs lower than JM1 BK**** ** 483440 (produced before January 27, 2006)

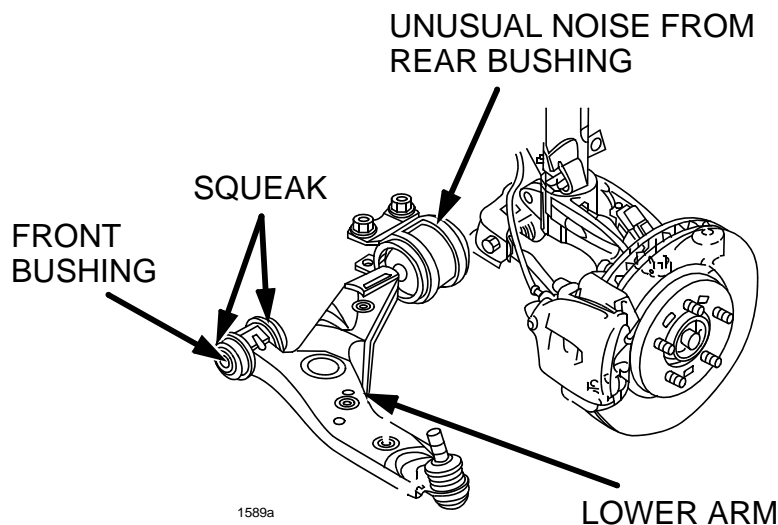
Some vehicles may exhibit a squeaking noise from the front suspension when passing over a bump at a low speed. This is may be caused by one of the following.

- The front lower arm making contact with the bushing, causing a squeaking noise.
- The fluid in the rear bushing makes an unusual noise.

1. Verify customer concern.
2. Replace front lower arm. Refer to appropriate Workshop Manual section 02-13 - FRONT LOWER ARM REMOVAL / INSTALLION.
3. Perform toe-in inspection and adjustment. Refer to appropriate Workshop Manual section 02-11 - WHEEL ALIGNMENT.
