Subject: POOR HEATER PERFORMANCE WITH DTC P011A:00	Bulletin No.: 07-007/17
	Last Issued: 09/08/2017

APPLICABLE MODEL(S)/VINS

2014-2016 Mazda3 Japan Built vehicles with VINs lower than JM1 BM ***** 355940 (produced before June 23, 2016)
2014-2016 Mazda3 Mexico Built vehicles with VINs lower than 3MZ BM ***** 330142 (produced before Sept 03, 2016)
2017-2018 Mazda3
2014-2016 Mazda6 vehicles with VINs lower than JM1 GJ ***** 488592 (produced before June 30, 2016)
2017 Mazda6
2017-2018 Mazda6 Mexico
2013-2017 CX-5 vehicles with VINs lower than JM3 KE ***** 921726 (produced before Dec 21, 2016)

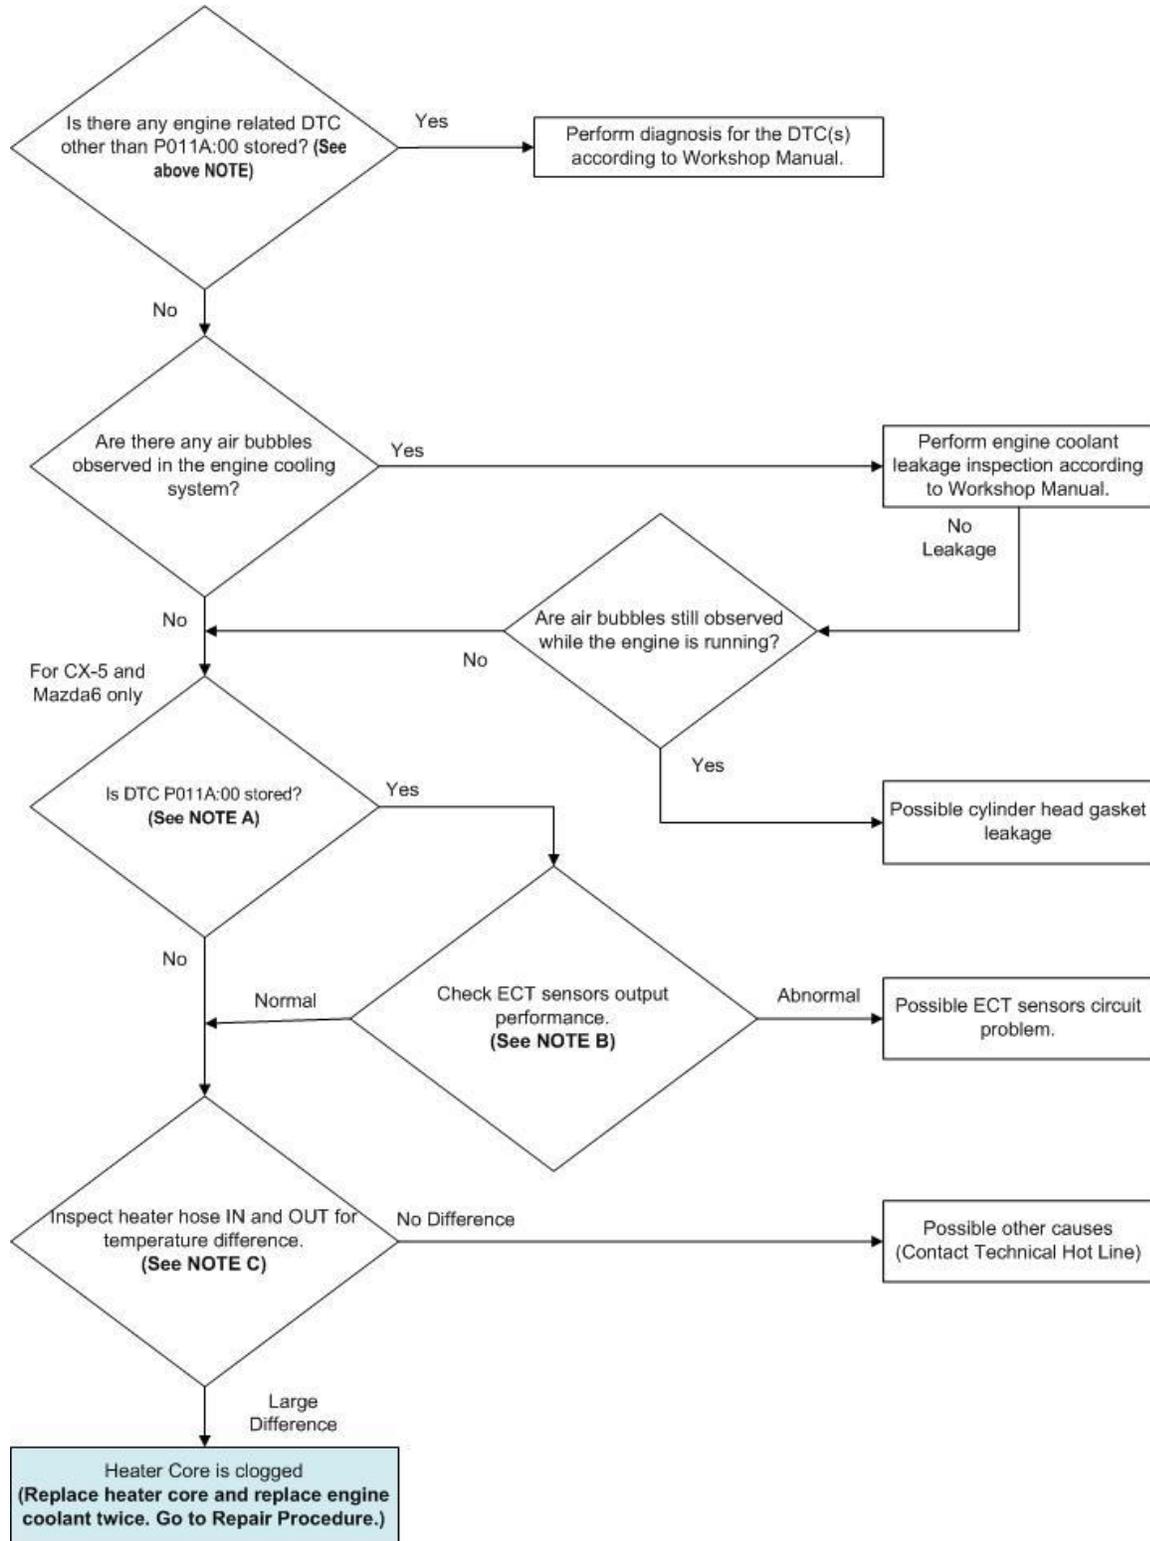
DIAGNOSIS PROCEDURE

Perform the following diagnosis procedure to determine if the concern is caused by a clogged heater core.

NOTE: DTC P011A:00 (ECT2 sensor on the heater hose) is available only for CX-5 and Mazda6.

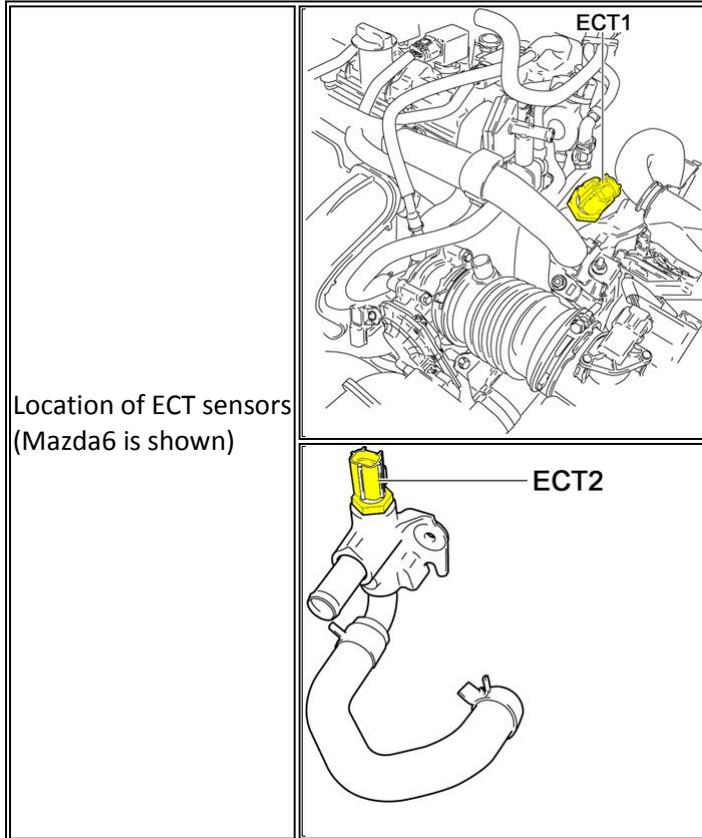
NOTE A: DTC P011A:00 (ECT sensor No.1/No.2 performance problem) is for CX-5 and Mazda6 only. The purpose of having two ECT sensors is to mutually monitor their performances. If two temperature values detected by the sensors are different beyond the specified value, the DTC P011A:00 is set.

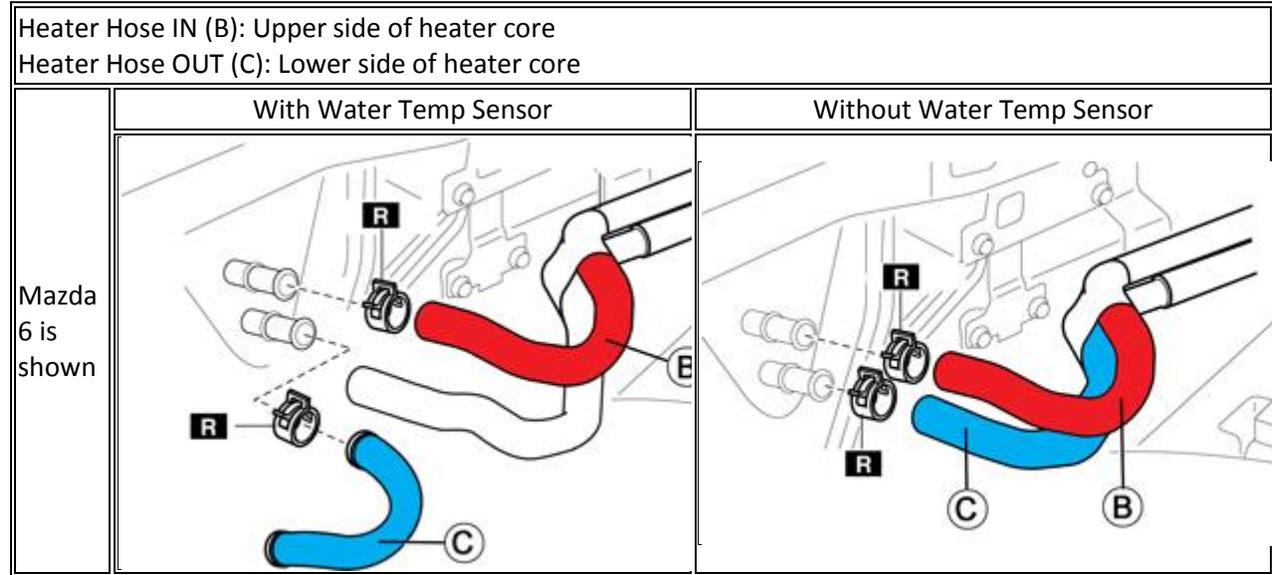
NOTE C: Inspect heater hose IN and OUT for temperature difference.

Using a thick cloth or gloves, touch the heater hose IN and heater hose OUT by hand to feel the temperature. If there is an obvious difference in temperature between both hoses, the heater core may be clogged.

NOTE: When doing this inspection, turn the HVAC blower fan OFF. If ON, the heater core radiates heat, so the temperature difference between IN and OUT hoses will generate heat even if the heater core is not clogged.

If clogging of the heater core was determined by the diagnosis procedure, replace the heater core with a new one and replace the contaminated engine coolant twice.
