# Technical Service Bulletin

<b>Subject:</b>  CHECK ENGINE LIGHT ON WITH DTC P0126:00	<b>Bulletin No.:</b> 01-005/23
	<b>Last Issued :</b> 12/20/2023

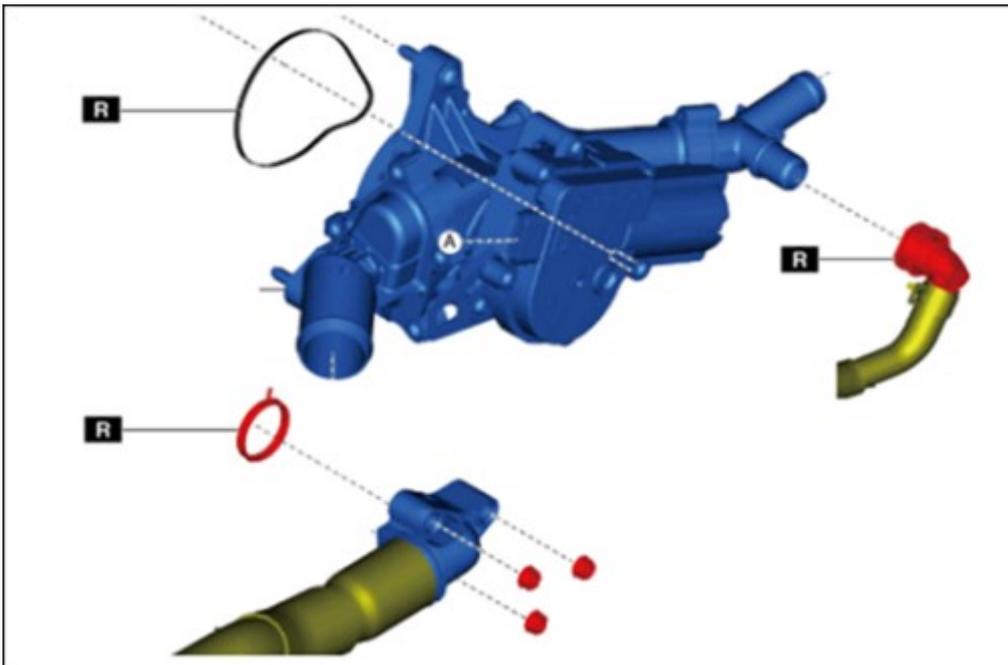
- O-ring
- Gasket
- Connector

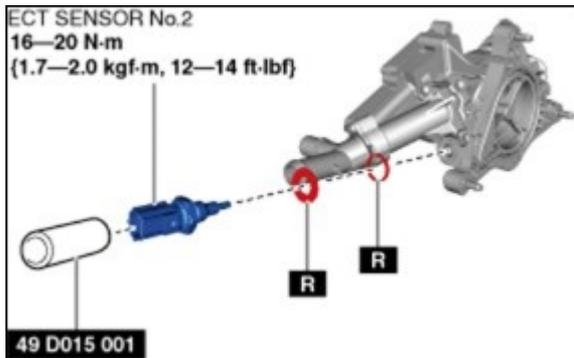
- O-ring and washer for ECT sensor No.2
