Service Information

Category S	Repair Guidance	Ref. No. R017/12C	Page 1 of 5
Coverage <input type="checkbox"/> Distributor only <input checked="" type="checkbox"/> Please inform your dealers		Date Issued February 23, 2012	
Please convey this information to your <input checked="" type="checkbox"/> Warranty Dept. <input checked="" type="checkbox"/> Parts Dept. <input type="checkbox"/> Director <input checked="" type="checkbox"/> General Manager <input checked="" type="checkbox"/> Training Dept. <input checked="" type="checkbox"/> Field Rep.		Date Revised July 20, 2012	
Applicable Model CX-5 (KE)	Applicable Countries or Specifications Worldwide

Subject: Rattle noise from instrumental panel and/or creak noise from A-pillar when driving on rough roads or over bumps

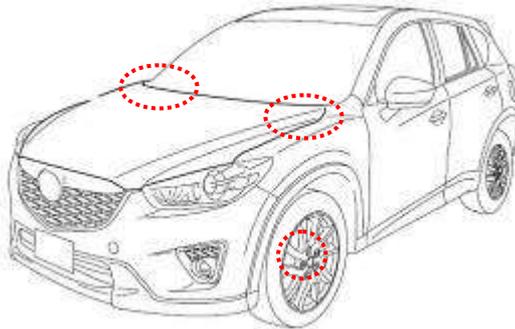
When driving on rough roads or over bumps, some vehicles may exhibit a rattle noise from the front of the instrumental panel and/or a creak noise from the bottom of the A-pillar.

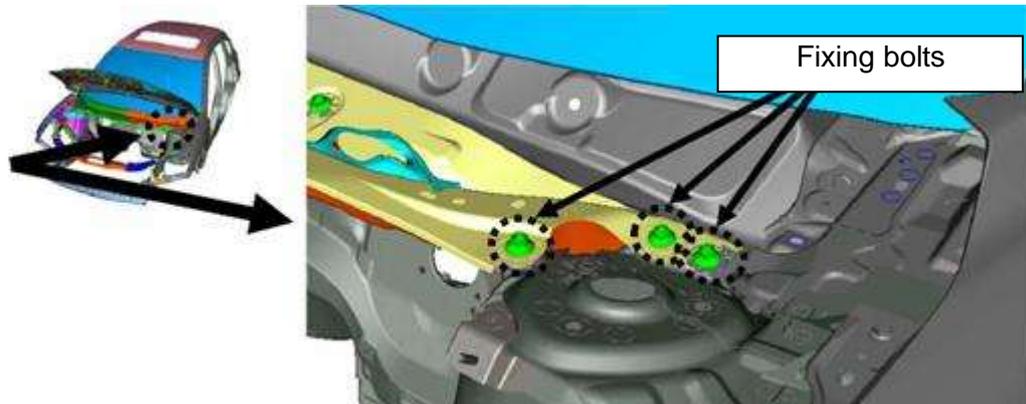
Low torque of cowl panel fixing bolts.

Torque control and inspection at production process has been improved.

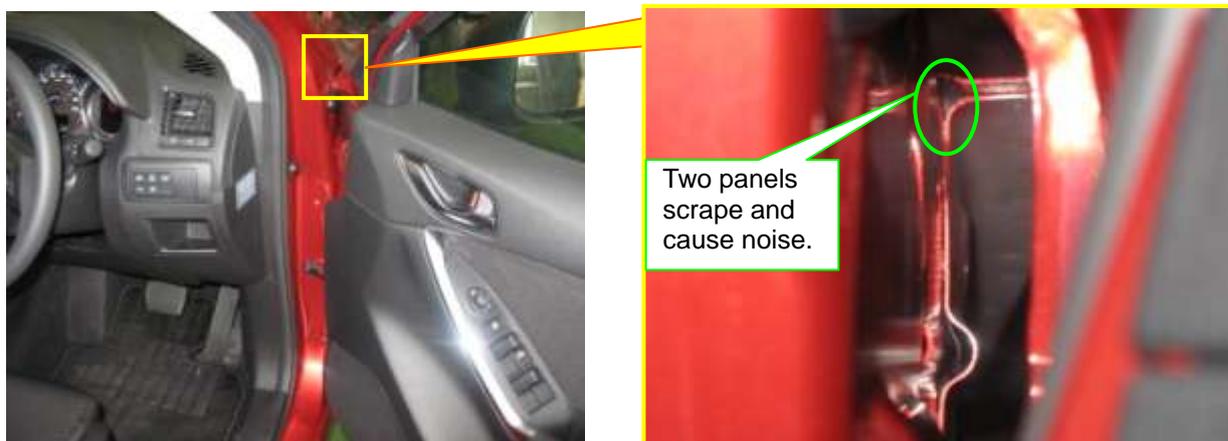
Two panels jointing at the bottom of the A-pillar scrape each other causing the noise.

The welding area has been optimized.

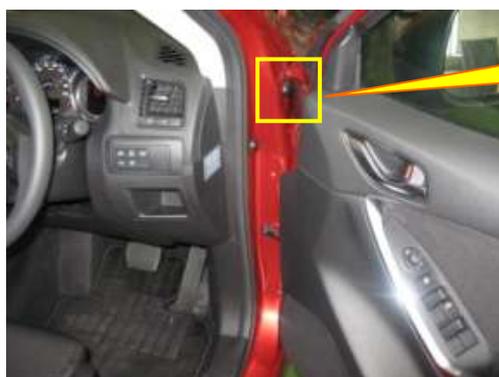
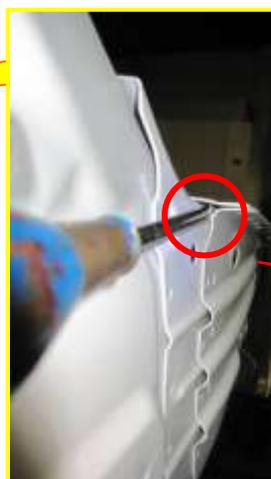
NOTE: In the picture, the front fender is removed to give a better view of the problem area. During the actual work, the removal is not necessary.

Enlarge the clearance between two panels at the problem side using an appropriate tool (a flat-blade screwdriver).

Produce clearance between two panels here.
