Service Information

Category S	Repair Guidance	Ref. No. R042/13A	Page 1 of 7
Coverage <input type="checkbox"/> Distributor only <input checked="" type="checkbox"/> Please inform your dealers		Date Issued June 21, 2013	
Please convey this information to your <input type="checkbox"/> Director <input checked="" type="checkbox"/> General Manager <input checked="" type="checkbox"/> Warranty Dept. <input checked="" type="checkbox"/> Parts Dept. <input checked="" type="checkbox"/> Training Dept. <input checked="" type="checkbox"/> Field Rep.		Date Revised August 6, 2013	
Applicable Model CX-5 (KE)		Applicable Countries or Specifications Europe

Subject: Outer mirror vibration when driving on highway

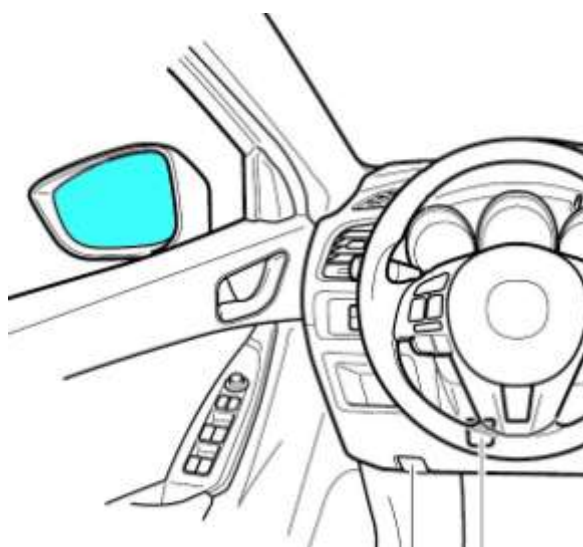
Some vehicles may exhibit a vibration on outer mirror when the vehicle is driven at high speed.

Due to a lack of rigidity of the outer mirror base, the mirror vibrates caused by vehicle vibration or wind pressure.
