Subject: MIL ILLUMINATES WITH DTC P0402 STORED IN MEMORY	Bulletin No: 01-007/02
	Last Issued: 2/25/2002

APPLICABLE MODEL(S)/VINS

All 1999-2001 Protege (1.6L)

All 1999-2000 Miata

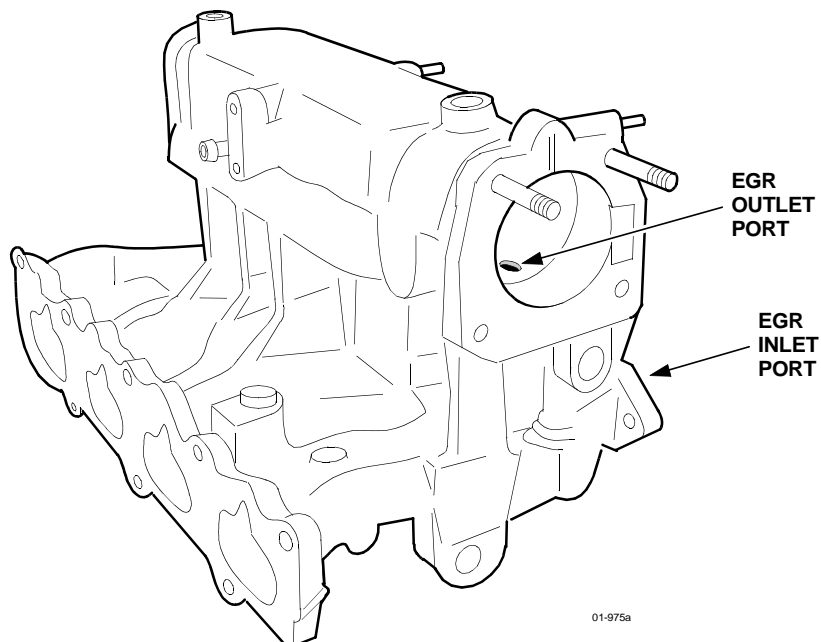
INTAKE MANIFOLD
(PROTEGE SHOWN)

The Malfunction Indicator Lamp (MIL) may illuminate with Diagnostic Trouble Code (DTC) P0402 stored in memory. This may be caused by carbon deposits accumulating at the Exhaust Gas Recirculation (EGR) exhaust outlet port, inside the intake manifold. This may cause pressure to increase inside the exhaust gas flow circuit, resulting in stored DTC P0402.

1. Verify customer concern.
2. Confirm Freeze Frame Data was set for DTC P0402.
3. Remove Throttle Body according to Workshop Manual section 01-13.
4. Remove EGR valve (for Protege), or Surge tank (for Miata) according to the applicable Workshop Manual.
5. Using appropriate tool, remove carbon from EGR outlet port.

Caution: On Protege, DO NOT allow scraped-off carbon to fall into surge tank. Only allow carbon to exit

through EGR port.

6. With compressed air, blow loosened carbon through EGR inlet port.
