# Service Information

| Category<br><b>S</b> | <b>Repair Guidance</b> | Ref. No.<br>R017/12C | Page<br>1 of 5 |
| Applicable Model<br><br>CX-5 (KE) | Applicable Countries or Specifications<br><br>Worldwide | | |

**Subject:** Rattle noise from instrumental panel **and/or creak noise from A-pillar**  
when driving on rough roads or over bumps

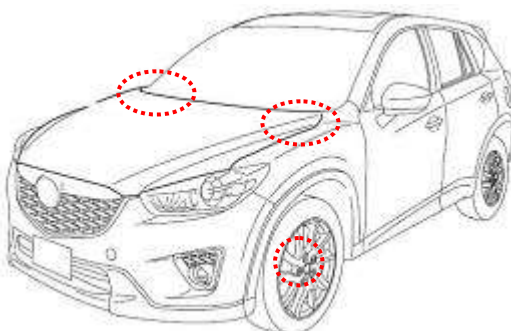
When driving on rough roads or over bumps, some vehicles may exhibit a rattle noise from the front of the instrumental panel **and/or a creak noise from the bottom of the A-pillar**.

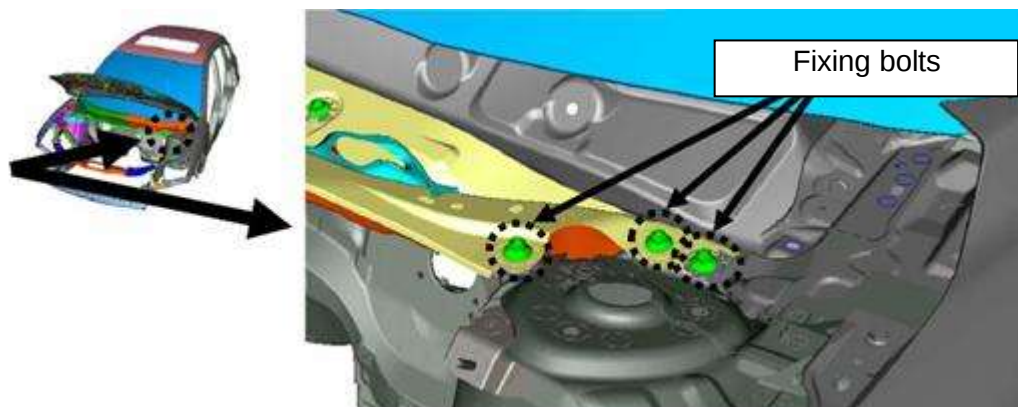
Low torque of cowl panel fixing bolts.

1. Remove the cowl grille according to Workshop Manual “COWL GRILLE REMOVAL / INSTALLATION”.
2. Retighten the cowl panel fixing bolts (both sides, total 6pcs).  
※Tightening torque: 22 - 30 Nm

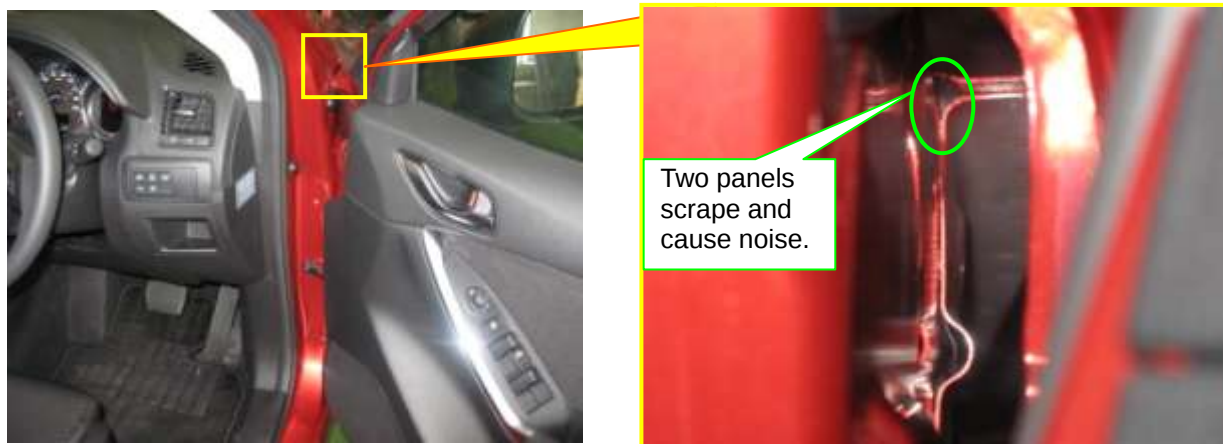
Two panels jointing at the bottom of the A-pillar scrape each other causing the noise.

Enlarge the clearance between two panels at the problem side using an appropriate tool (a flat-blade screwdriver).
