**EXCESSIVE OPERATING NOISE WHEN SLIDING POWER SEAT**

**Bulletin No:** 09-021/13

**Last Issued:** 07/19/2013

2014 Mazda6 equipped with power seats with VINs lower than JM1GJ\*\*\*\*\*125980 (produced June 1, 2013)

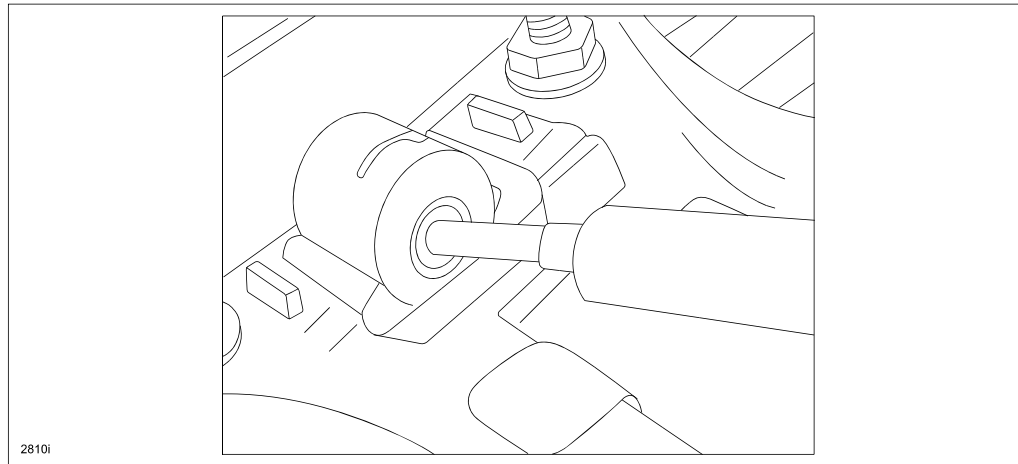
- If the cable is bent too much during installation, operation noise may occur. DO NOT hold the cable around the tip.

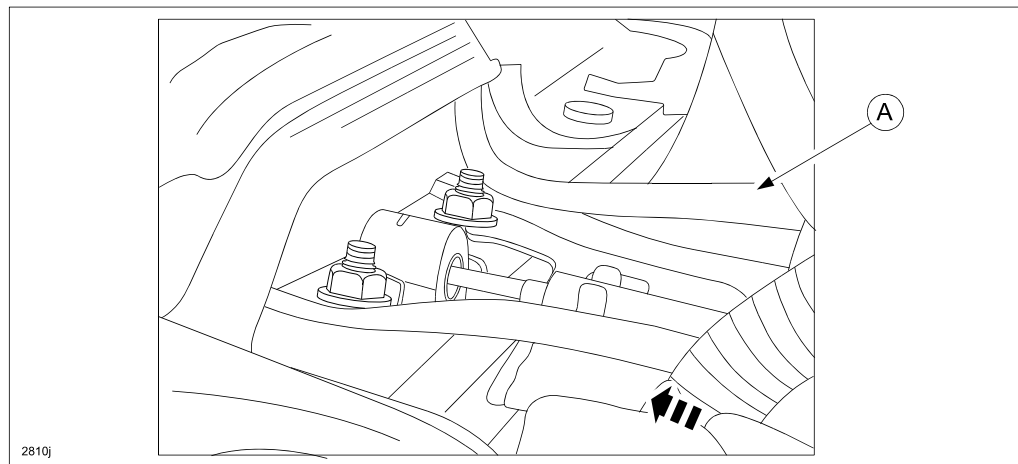
- If work space is too dark to see properly, use a light to illuminate the spot where the cable should be installed.
- Take caution not to pinch the seat belt buckle harness (A).

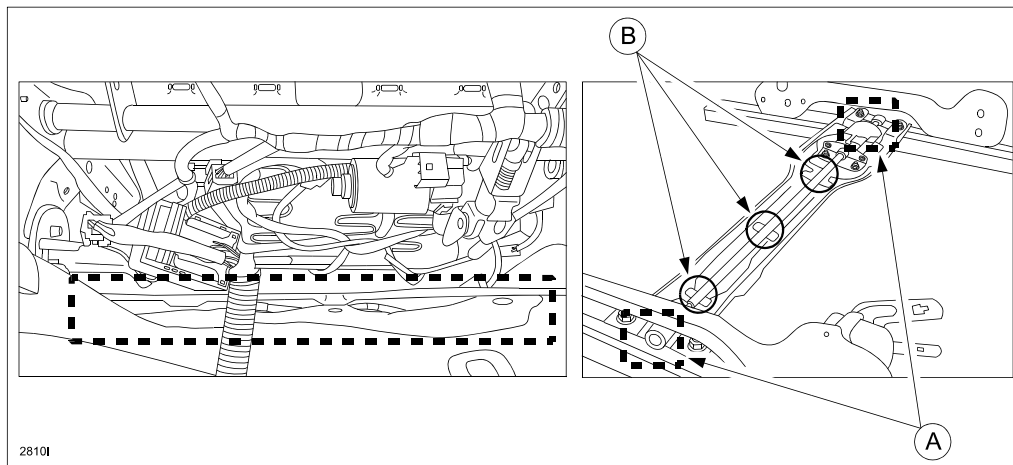
- The cable is not curved or floating.
- The cable is properly installed into the motor side and gear box side (A).
- The cable is properly secured to the seat frame at each cable bracket (B).

14. Look under the seat and verify the following points:
