Technical Service Bulletin

**MAZDA CONNECT REBOOTS OR SCREEN TURNS BLACK DURING
COLD TEMPERATURES**

Bulletin No.: 09-001/18

2014-2018 Mazda3	2016-2017 CX-3
2016-2017 Mazda6	2016-2017 CX-5
2016-2017 MX-5	2016-2017 CX-9

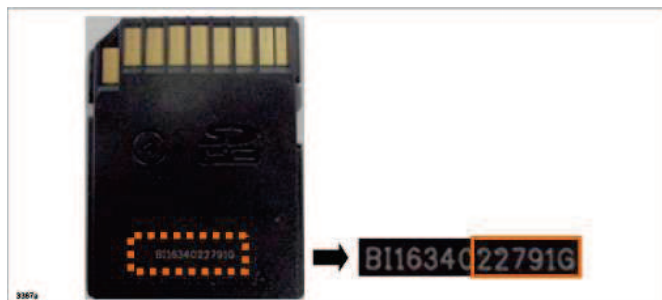
1. Verify customer concern.
2. Remove the SD card and check the last 6 digits of the lot number on the SD card.

- If the SD card has any of the following 6 digit lot numbers, replace it with a new SD card.

50424D	50631D	50635G	50881G	50955G
50428G	50632G	50877D	50913D	50995G
