<b>Subject:</b>  DRIVER'S DOOR DOES NOT LOCK	<b>Bulletin No:</b> 09-041/06
	<b>Last Issued:</b> 10/12/2006

2006 Mazda5 vehicles with VINs lower than JM1CR\*\*\*\*\*125692 (produced before April 17, 2006)

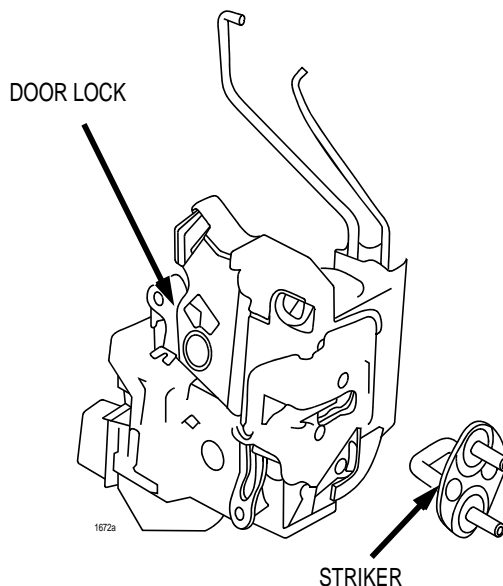
On some vehicles, the driver's door can be opened from the outside after it is locked with the key or the remote transmitter and the door lock inside the vehicle indicates the door is locked. This is caused by the lock lever of the door lock moving out of position. To fix this problem, the lock position of the lock lever has been enlarged.

1. Verify customer concern.
2. Record the customer's radio station presets.
3. Disconnect the negative battery cable.
4. Replace the driver's door lock assembly (door latch and lock actuator) and door lock striker with modified ones. Refer to Workshop Manual section 09-14 FRONT DOOR LATCH AND LOCK ACTUATOR REMOVAL/INSTALLATION and 09-14 DOOR LOCK STRIKER REMOVAL/INSTALLATION.
