# Service Information

Category <b>S</b>	<b>Repair Guidance</b>	Ref. No. R083/13A	Page 1 of 6
Coverage <input type="checkbox"/> Distributor only <input checked="" type="checkbox"/> Please inform your dealers		Date Issued November 19, 2013	
Please convey this information to your <input type="checkbox"/> Director <input checked="" type="checkbox"/> General Manager <input checked="" type="checkbox"/> Warranty Dept. <input checked="" type="checkbox"/> Parts Dept. <input checked="" type="checkbox"/> Training Dept. <input checked="" type="checkbox"/> Field Rep.		Date Revised October 16, 2017	
Applicable Model  CX-5 (KE)		Applicable Countries or Specifications  Worldwide

## Subject: White Stains under Power Outer Mirror Base

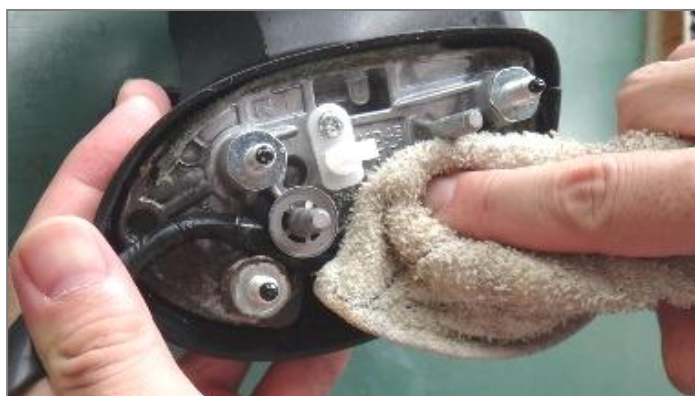
- 4) Remove the masking tape and then wipe water off the mirror base and let it dry.

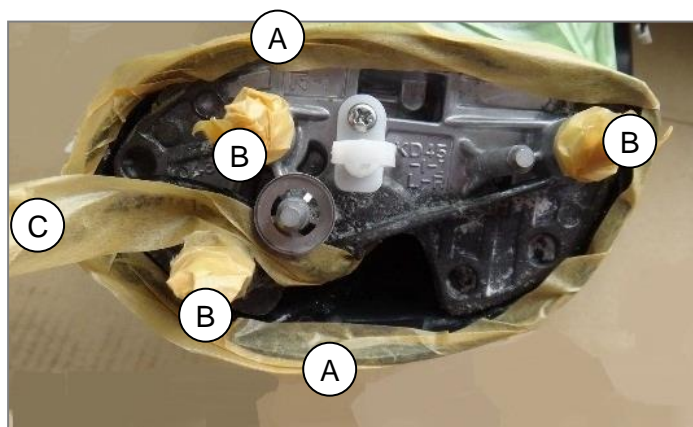
- 1) To prevent wax from adhering to the mirror base cover (A), stud bolts (B) and harness (C), put masking tapes as shown in figure.

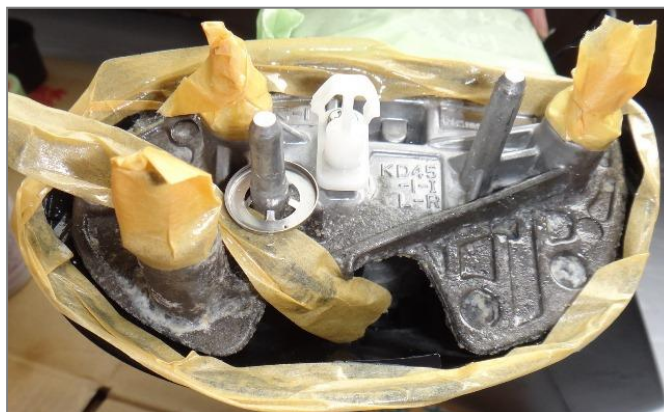
- 2) Apply anti-corrosion wax to the mirror base.  
Recommended anti-corrosion wax:  
Würth Protective Wax Transparent (0893 082) or equivalent

- 3) Let the anti-corrosion wax dry naturally.
- 4) Remove the masking tape.

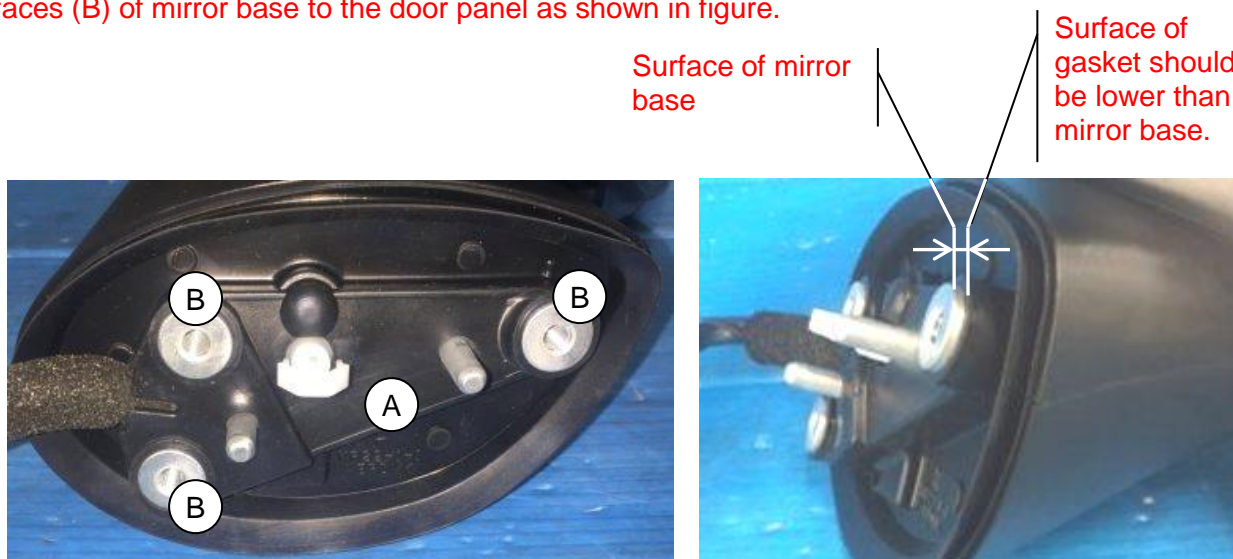
**NOTE:** Install the gasket (A) to the mirror base so that the gasket comes under the installation surfaces (B) of mirror base to the door panel as shown in figure.
