2013 - CX-5 - Body and Accessories

DECORATION PANEL REMOVAL/INSTALLATION

AUDIO UNIT REMOVAL/INSTALLATION

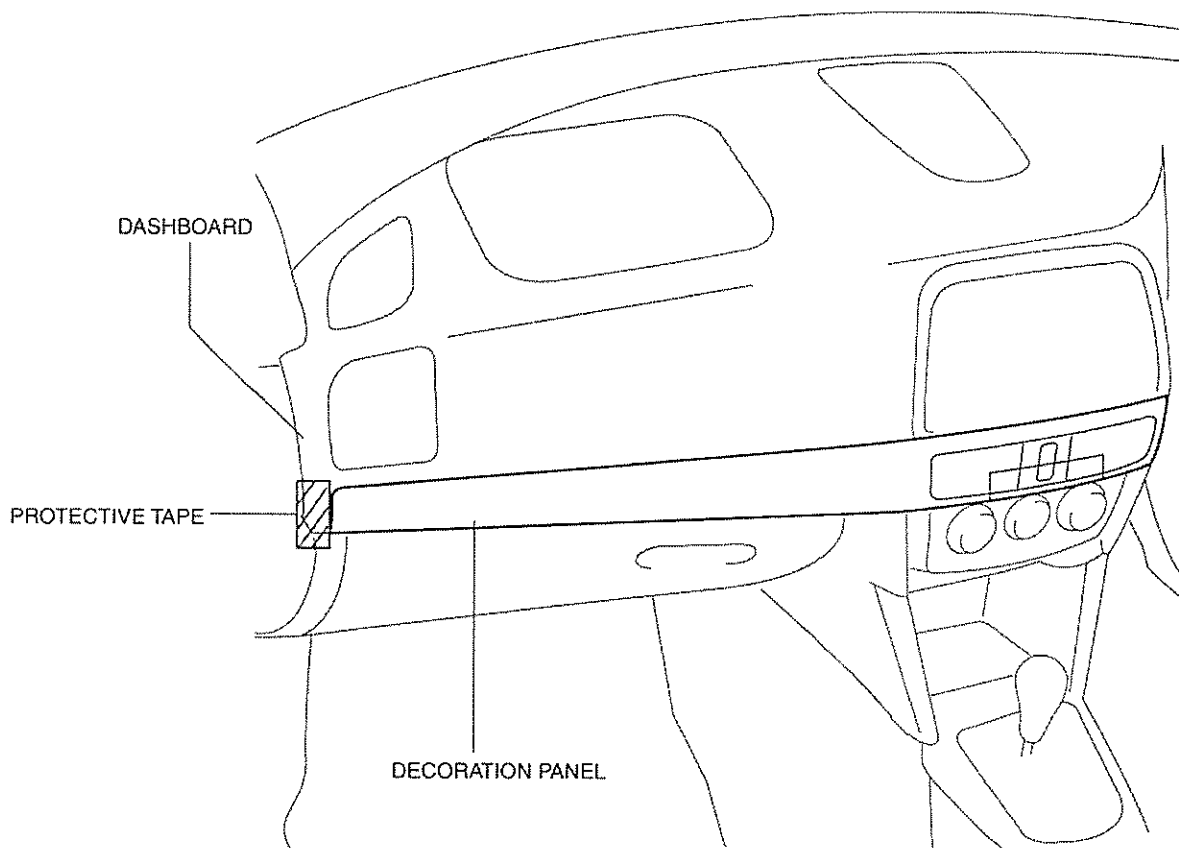
- Affix protective tape to the position shown in the figure.

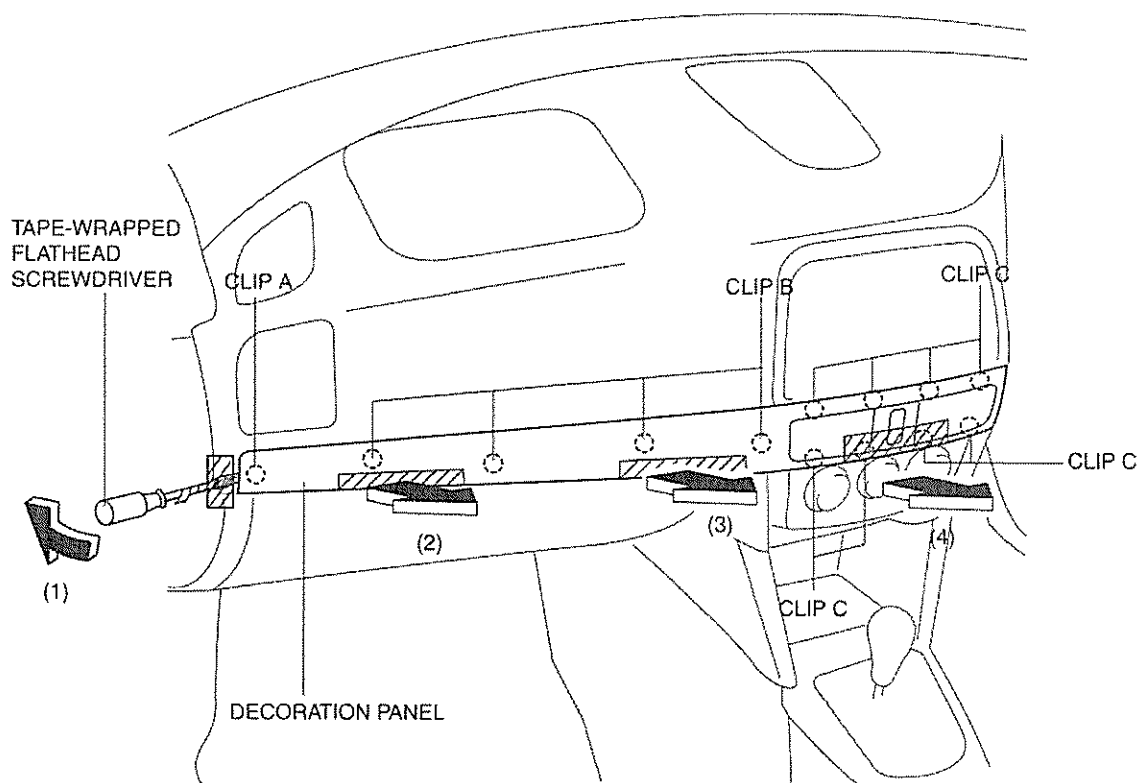
1. Disconnect the negative battery cable. (See [NEGATIVE BATTERY CABLE DISCONNECTION/CONNECTION \(SKYACTIV-G 2.0\)](#).)
2. Open the glove compartment.
3. Insert a tape-wrapped flathead screwdriver in the position indicated by the arrow (1) in the figure and detach clip A.

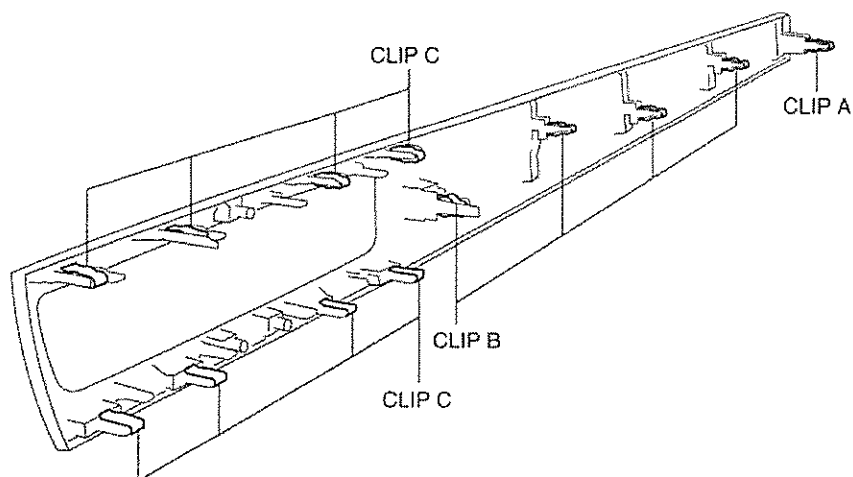
4. Take the shaded area shown in the figure, and remove the decoration panel in the direction of the arrow in the order of (2), (3), (4) while detaching clips B, clips C.
5. Disconnect the hazard switch connector.
6. Install in the reverse order of removal.

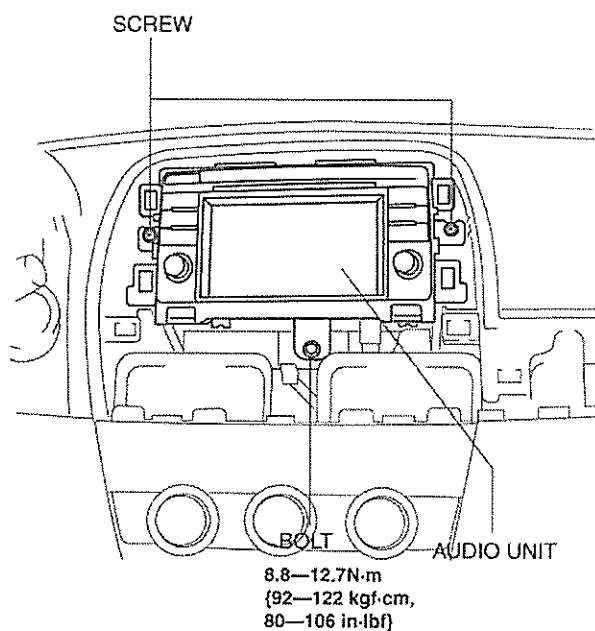
1. Disconnect the negative battery cable.
2. Remove the decoration panel. (See [DECORATION PANEL REMOVAL/INSTALLATION](#).)
3. Remove the bolt.

4. Remove the screws.

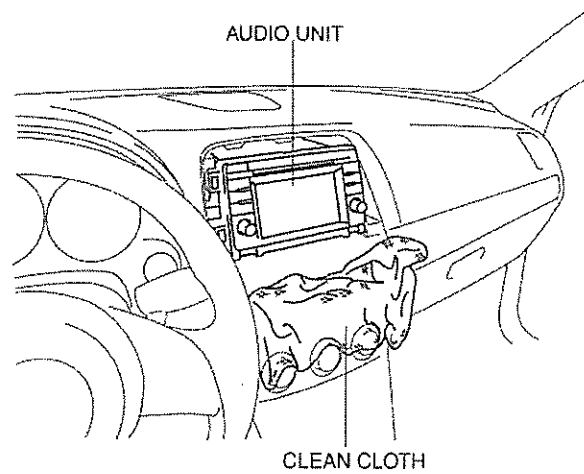
- When removing the audio unit, the audio unit could interfere with the climate control unit and scratch the climate control unit. Perform the servicing by spreading a cloth in the position indicated in the figure.

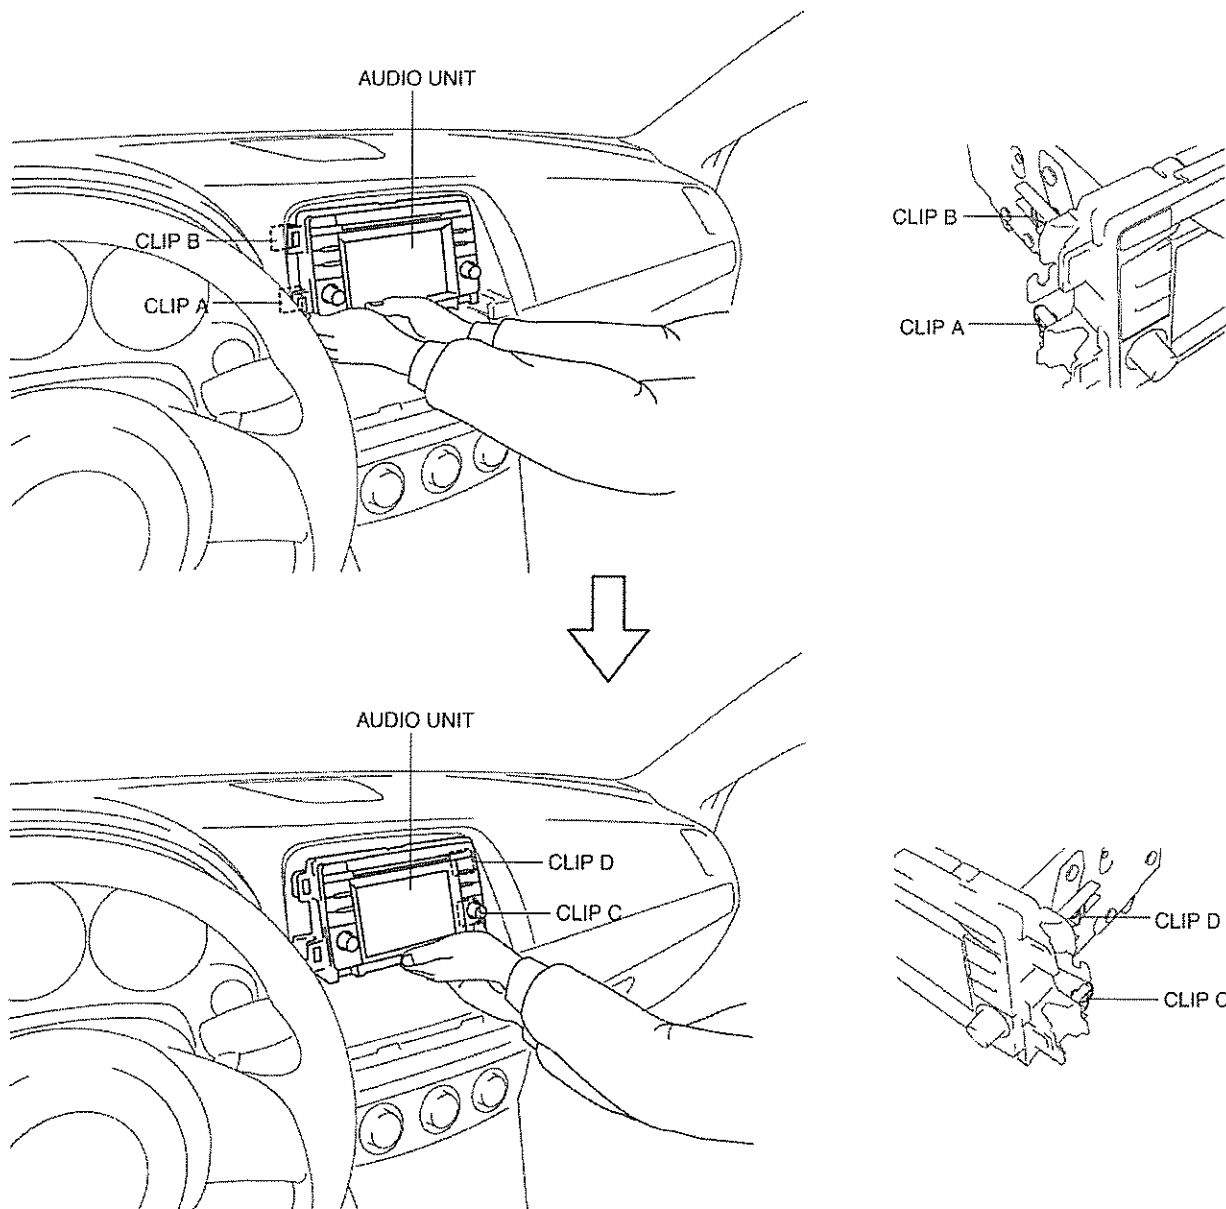
5. Hold the audio unit in the position shown in the figure and pull it outward to disengage clips A, B, C, and D from the instrument panel.

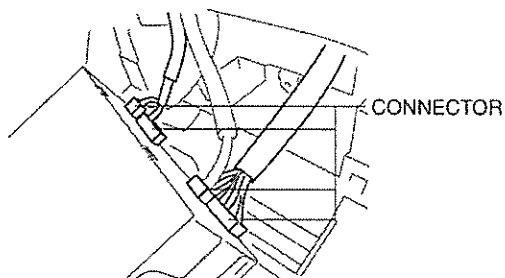
WITHOUT COLOR LCD

6. Disconnect the connectors.

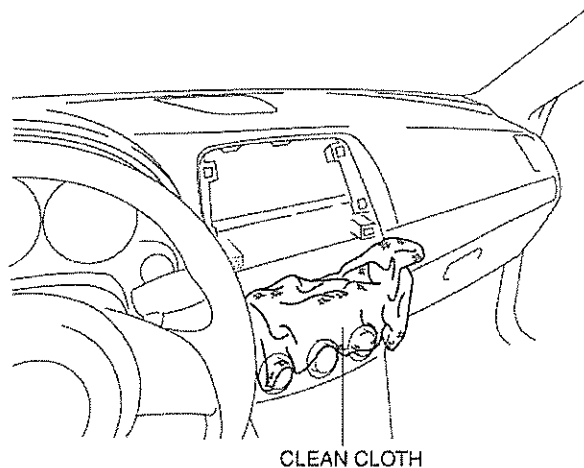
- When installing the audio unit, the audio unit could interfere with the climate control unit and scratch the climate control unit. Perform the servicing by spreading a cloth in the position indicated in the figure.

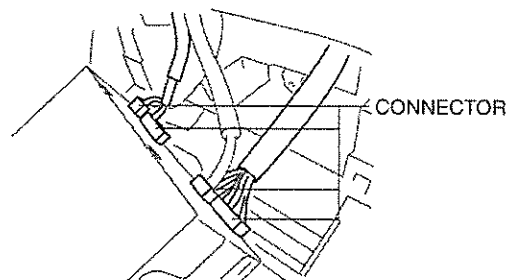
WITHOUT COLOR LCD

1. Connect all the connectors.

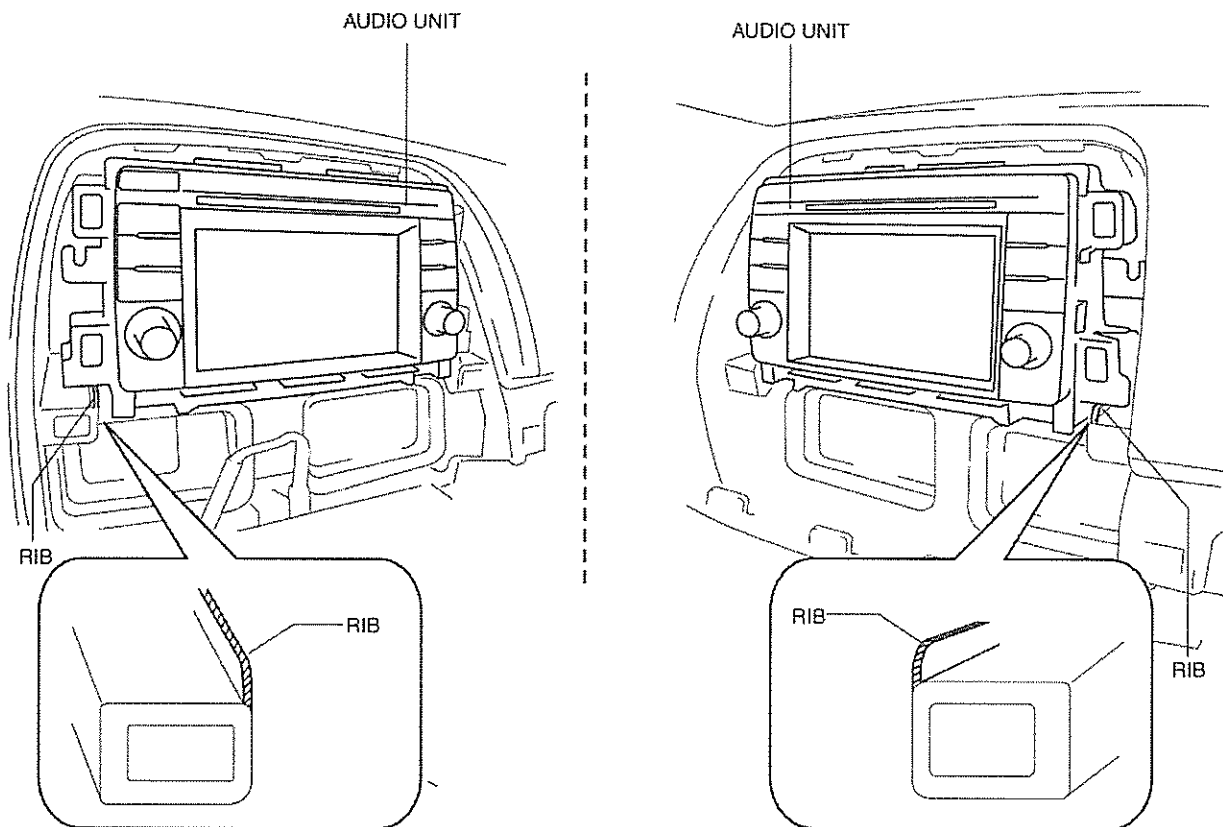
2. Temporarily position the audio unit on the ribs and align the hole positions of the instrument panel with clips.

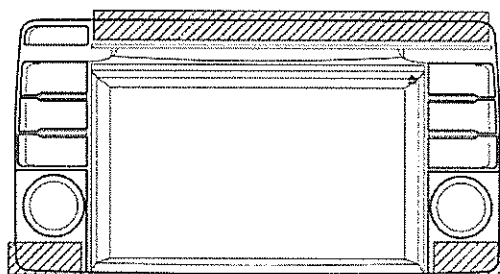
WITH COLOR DISPLAY

3. Press the audio unit in the position shown in the figure and engage clips to the instrument panel.

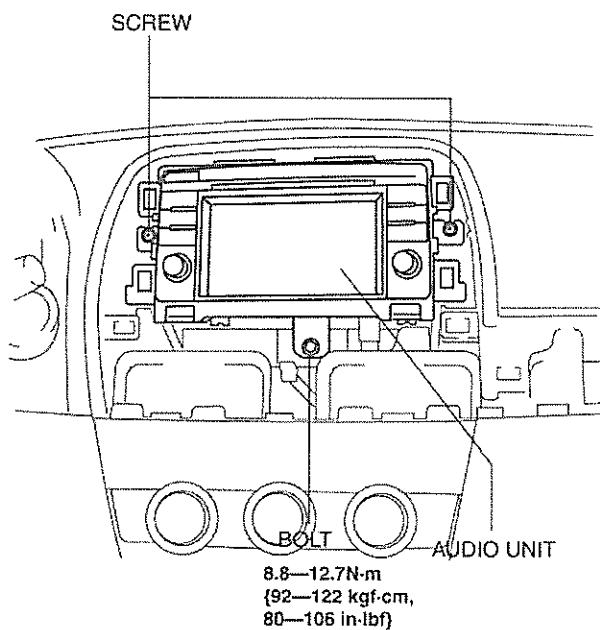
4. Install the screws.

5. Install the bolt.
