# Service Information

Category <b>P</b>	<b>Repair Guidance</b>	Ref. No. R052/16 <b>C</b>	Page 1 of 6
Coverage <input type="checkbox"/> Distributor only <input checked="" type="checkbox"/> Please inform your dealers		Date Issued June 20, 2016	
Please convey this information to your <input checked="" type="checkbox"/> Warranty Dept. <input checked="" type="checkbox"/> Parts Dept. <input checked="" type="checkbox"/> Training Dept. <input checked="" type="checkbox"/> Field Rep.	<input type="checkbox"/> Director <input checked="" type="checkbox"/> General Manager	Date Revised February 24, 2017	
Applicable Model  CX-5 (KE) with Electric Parking Brake (EPB)	Applicable Countries or Specifications  Worldwide

## Subject: Noise from REAR BRAKE/Trace of Rear Brake Dragging

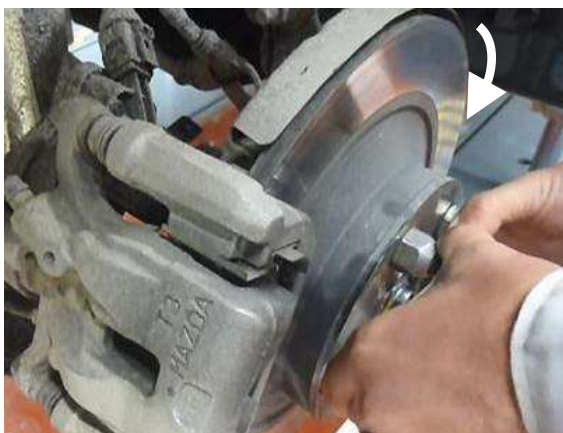
- ④ Verify that that disc plates rotate by hands as shown in figure.
- If the disc plate does not rotate, the affected side caliper is defective. Go to REPAIR PROCEDURE.
  - If the both disc plates rotate smooth, go to next step.

If the caliper has been found to be defective by the diagnosis procedure, replace the affected side caliper(s) with a modified one(s) according to the workshop manual “REAR BRAKE (DISC) REMOVAL/INSTALLATION” and “ELECTRIC PARKING BRAKE MOTOR GEAR UNIT REMOVAL/INSTALLATION”.

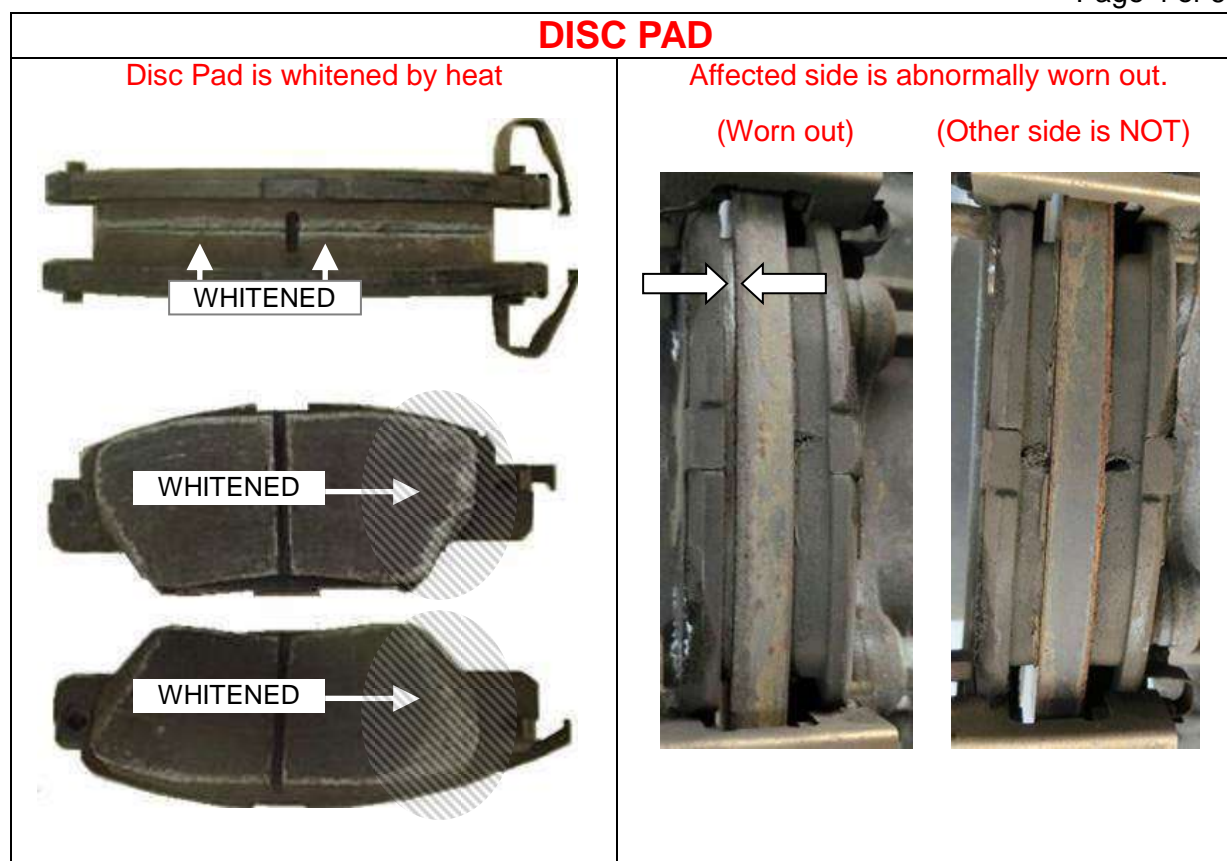
<p>WHITENED</p>

- 4) Check the disc plates and disc pads for damage/discoloration by brake dragging.
- If one or more of conditions specified below is/are found, it indicates brake dragging and the affected side caliper is defective. Go to REPAIR PROCEDURE.
  - If the disc plates and pads are in normal condition, the problem does not exist. This Service Information is not applicable.

<p>BLUISH BLACK</p>	<p>Area not contacting disc pad is whitened by heat.</p>

**NOTE:** If the disc plate(s)/disc pad are damaged, inspect and replace the affected side(s) as necessary according to the workshop manual “REAR BRAKE (DISC) REMOVAL/INSTALLATION” and “DISC PAD (REAR) REPLACEMENT”.
