Subject: POOR HEATER PERFORMANCE WITH DTC P011A:00	Bulletin No.: 07-007/17
	Last Issued: 09/08/2017

APPLICABLE MODEL(S)/VINS

2014-2016 Mazda3 Japan Built vehicles with VINs lower than JM1 BM ***** 355940 (produced before June 23, 2016)
2014-2016 Mazda3 Mexico Built vehicles with VINs lower than 3MZ BM ***** 330142 (produced before Sept 03, 2016)
2017-2018 Mazda3
2014-2016 Mazda6 vehicles with VINs lower than JM1 GJ ***** 488592 (produced before June 30, 2016)
2017 Mazda6
2017-2018 Mazda6 Mexico
2013-2017 CX-5 vehicles with VINs lower than JM3 KE ***** 921726 (produced before Dec 21, 2016)

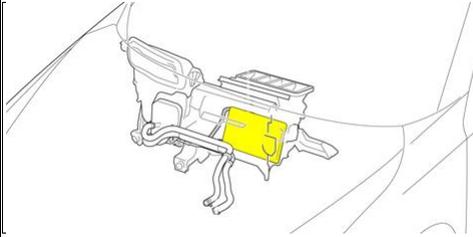
Mazda6 images are shown		
<p>Heater Unit Core</p>

Some customers may complain about poor heater performance even after the engine reaches normal operating temperature. This may be caused by a clogged heater unit.

If clogging of the heater core was determined by the diagnosis procedure, replace the heater core with a new one and replace the contaminated engine coolant twice.
