**OUTSIDE TEMPERATURE IS DISPLAYED LOWER THAN ACTUAL TEMPERATURE,
RESULT IN CABIN AC DOES NOT WORK SUFFICIENTLY AS IT SHOULD.**

Applies to the Following Mazda's with FULL AUTO AC (Air Conditioning) ONLY.

The North American TSB NUMBER is : 07-002/23 Dated Feb, 2023.

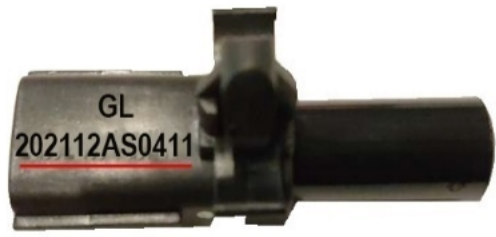
Ambient Temperature Sensor	
<p>LOT Number <u>202112AS0411</u></p> <ul style="list-style-type: none">• First 4 digits - <u>Year</u>• Digit 5-6 - <u>Month</u>• Digit 7-8 - Production Line Identification Code• Last 4 digits - <u>Product Lot (number assigned to each lot)</u>

<p>Example: 2021 12 AS 0411 = Dec/2021 Lot Number 411</p>

Above Image of Sensor is Mazda Part Number G518-61-764A.

This DEFECT ONLY applies to the lot numbers made before Lot 0411 of December 2021.

Any Sensor made AFTER Lot 0411 of December 2021 is not considered defective and this Bulletin does Not apply, if you still have any AC issues it may be related to something else other than this Temp Sensor.

Only the physical examination of the Sensors outer production label on Sensor will determine if it is considered defective.
